Walkthrough Condition Survey Report

<i>Name Of the Vessel</i>	E●●●●m	<i>Flag</i>	USA
<i>Port of Hail</i>	Wilmington, Delaware	<i>Documents To The Vessel</i>	Boat Registration Certificate, No. DL●●●F, See Attachment 18.3 and 18.4.
<i>HIN</i>	FR-SP●●●●B●● HIN not affixed to hull starboard aft in breach of standards. Secondary HIN was located with help of manufacturer and was seen by Surveyor. HIN should be affixed in retro to hull in manner prescribed by ISO 1●●●●

<i>Date of Manufacture</i>	201●	<i>Manufacturer</i>	Jeanneau/ SPBI/ France
<i>Length o A</i>	17.78m	<i>Type Of Vessel</i>	Sailing Yacht, Jeanneau 57, S057D
<i>Length o D</i>	17.28m	<i>Material hull, deck, superstructure</i>	GRP
<i>Draft</i>	2.25m	<i>B_{max}</i>	5.00m

<i>Survey's Scope</i>	Walkthrough Condition Survey
<i>Surveyor(s) on Site</i>	Capt. Naci Arıcı and Mr. Cem Baykent, BSc.
<i>Date, Time And Place of Survey</i>	14.●●.201●, 10:15 – 16:45, Göcek, Turkey
<i>Met Conditions during the Survey</i>	At times heavy rain, impairing work to some degree
<i>Those Present During Survey</i>	Capt. O●●● U●●●, Skipper; Mr. E●●● Ö●●●, Jeanneau Turkey
<i>Afloat/ On Hard</i>	Both
<i>Instructor</i>	Mr. G●●● Y●●●, Israel

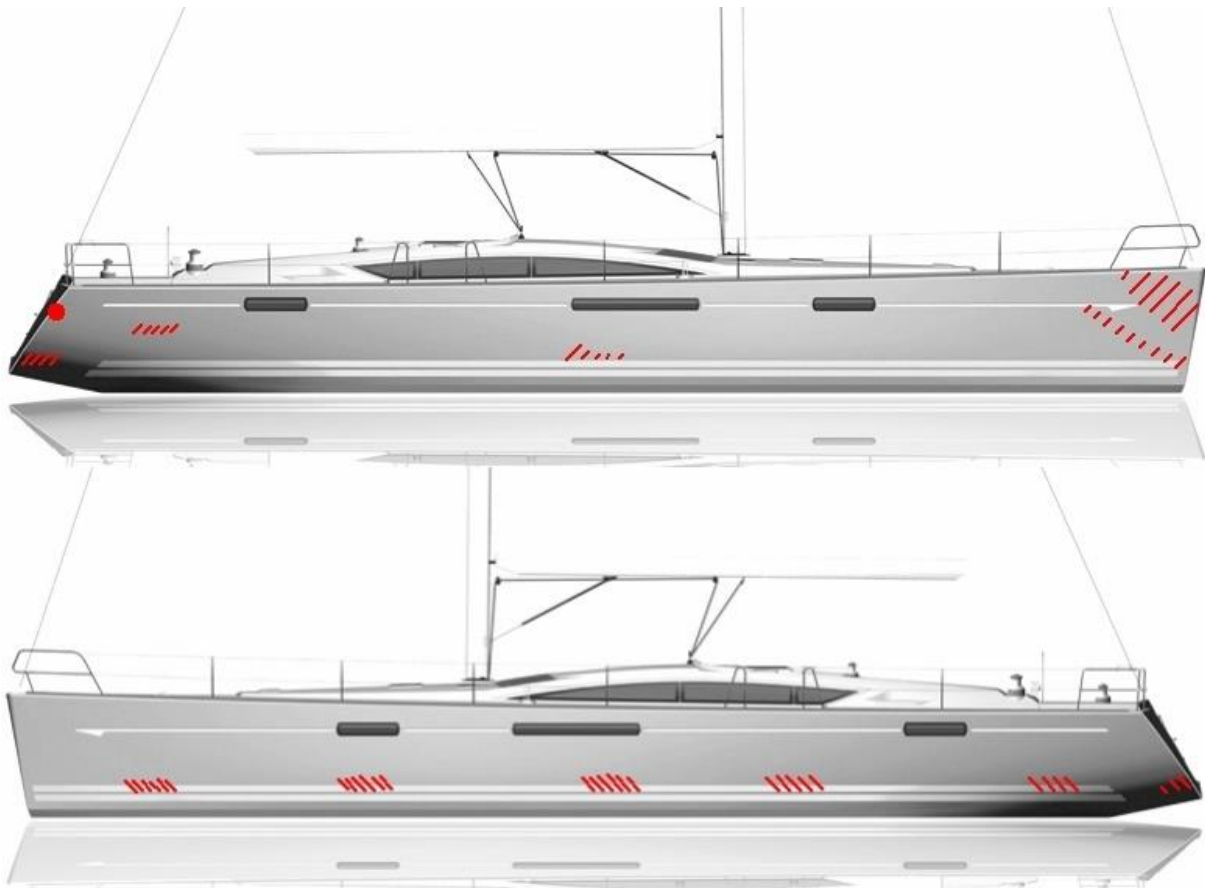
8.2 Damaged Areas to Transom and Topsides

Topsides and transom have been damaged by numerous impact, chafe and scratches. These are numerous and are subject to the drawing under Section 8.2. Some damages are due to a mishandled anchor, others due to fender or jetty chafe, yet others due to uncontrolled impact of the tender.

The damages are minor and do not form any structural hazard. However their sheer quantity makes **Surveyors recommend spraypainting of entire topsides**, at least on the port side.

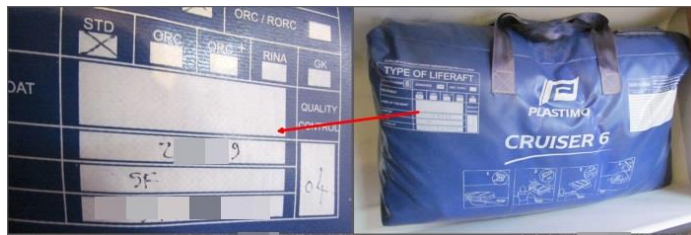
Plastimo Cruiser 6 (s/n ●●●●K●●●●). **Second liferaft is recommended when cruising with more than 6 persons on board.**

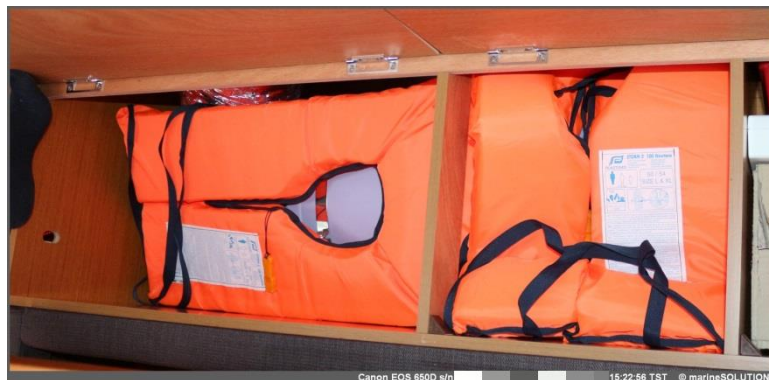
5 x Plastimo Storm 2, 100 Newtons. **More life vests required in accordance to the number of the cruising people.**
