REPORT

Pre-Purchase Condition Survey Report**1 Particulars of the Vessel**

<i>Name Of the Vessel</i>	S●●●●	<i>Flag</i>	British
<i>Port of Hail</i>	London	<i>Documents To The Vessel</i>	Certificate of Registry (See Attachment 23.2) Tonnage Certificate (See Attachment 23.1)
<i>HIN</i>	n/a	<i>Design Cat.94-25-CE</i>	n/a
<i>Date of Manufacture</i>	20●●	<i>Registration Number</i>

<i>Survey's Scope</i>	Pre Purchase Condition Survey
<i>Surveyor(s) on Site</i>	Tufan Tunalı, Nav. Arch, Yusuf Civelekoğlu, CMI
<i>Date, Time and Place of Survey</i>	7.●●.20●●, 14:30 – 21:45, 8.●●.20●●, 10:00 – 19:15, 9.●●.20●●, 09:45 – 13:15 ¹ Porto Mirabello, La Spezia, on hard and at berth; and in the Bay of La Spezia, seatrial on 7.●●.20●●
<i>Met Conditions during the Survey</i>	Very hot, over 35 °C, and very humid.
<i>Those Present during Survey</i>	Staff from the manufacturing yard. Surveyor P●●● R●●● at times.
<i>Afloat/ On Hard</i>	Both
<i>Instructor</i>	Mr. O●●● E●●●, N●●●●●●● T●●●

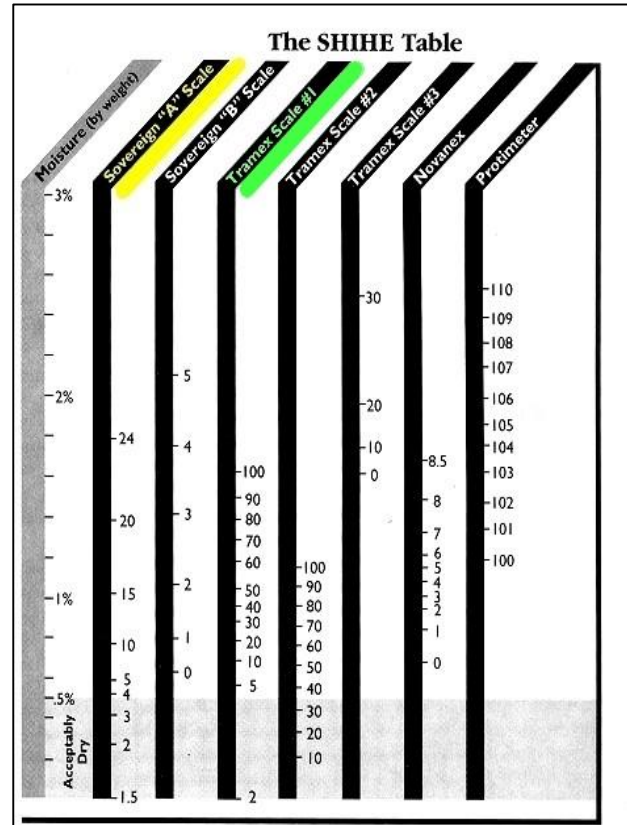
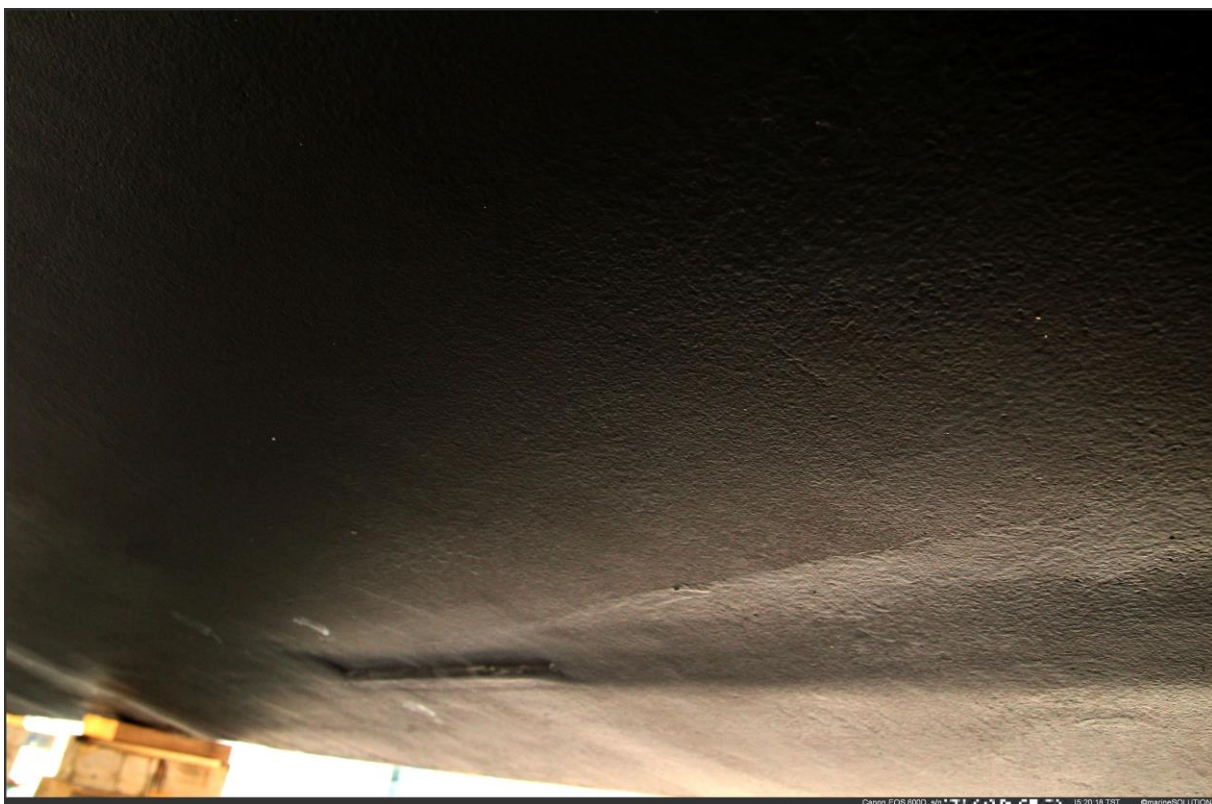
7.1.1 Hull Damage near to Keel

We noted an approx. 10 meter length concave deformed area approx. 40 cm to starboard of centreline and 15 – 20 cm wide. Within this there was an approx. 150cm x 30cm somewhat crudely patched area, 2 meters forward from saloon starboard side door vertical projection. This area is placed under a large structural fuel tank. We inspected corresponding

accessible areas from inside and were unable to locate any damages or hit marks. The outside appearance was rough, however, moisture content and tapping test results of this area were satisfactory. Area needs to be investigated from inside tank. Some further issues, possibly in relation with this damage and related to the props and shafts have been discussed in Section 22 below. Please also note our comments concerning recent rushed painting of bilges in the relevant Section.

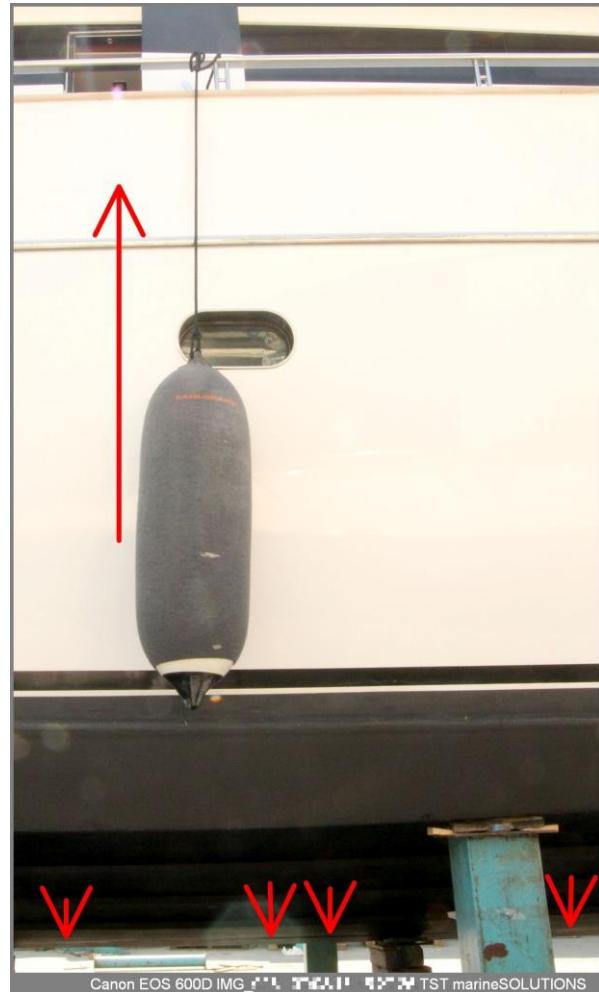
Right: Location of the repaired hull damage.

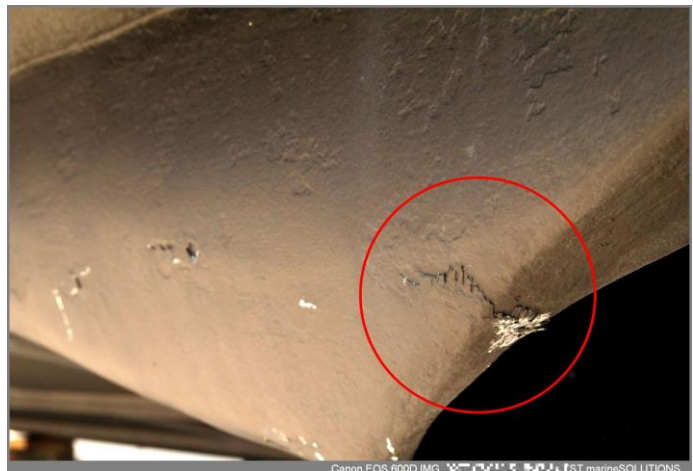
7.1.2 Port main engine underwater exhaust cowl

We visually noted a roughly repaired damage on portside exhaust cowl and corresponding cracks in the related exhaust tube. In particular there was an approx. 50 cm longitudinal partial delamination along the portside exhaust cowl inboard. This could be due to improper pressure, exerted, for instance, by slings during drydocking. Furthermore, the area has been repaired in a rough and improper manner. We noted also elevated moisture, about 60 units on Tramex Scale 1, in the subject area.

Right: Exhaust cowl repair (detail)

Attachment of cowl to hull is affected, structure is not affected. In order to carry out repairs, the Vessel has obviously to be drydocked. This area needs to be repaired at the next occasion, in the interim the area must be closely followed up and must be repaired without delay should the damage starts to grow. No such damages were noted on the starboard main exhaust cowl.

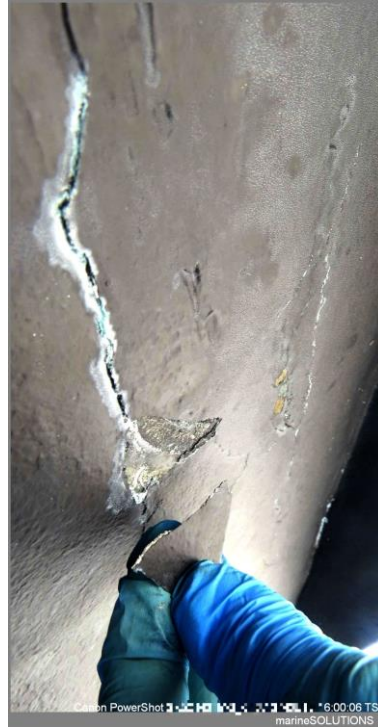
Exhaust cowl repair (general view)

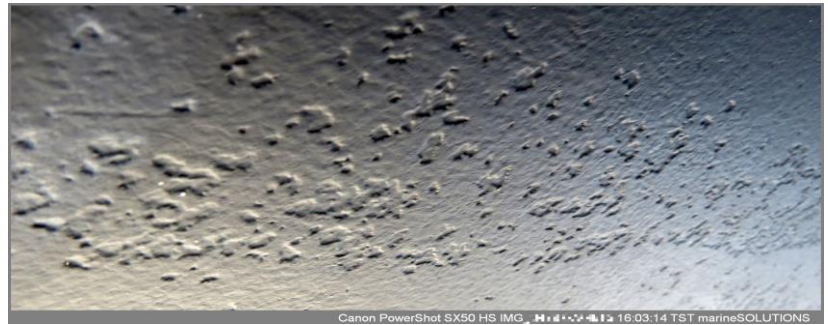
Furthermore, entire antifouling surface has turned porous and irregular due to frequent and inappropriate application.

Thought should be given to scrape back present antifouling paint and rebuilt protective epoxy coat, primer and antifouling from scratch.

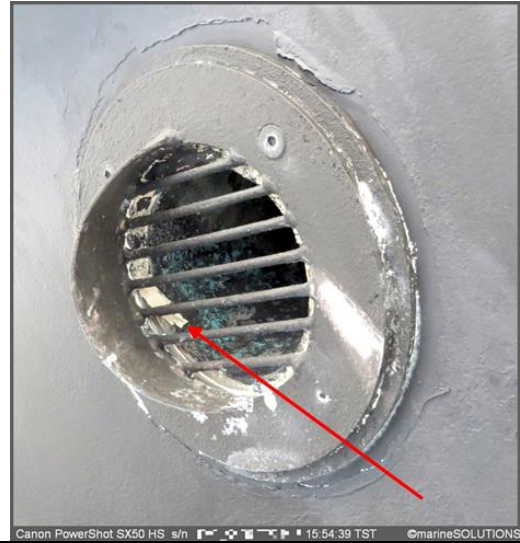
Main engines' seawater inlet thru-hull fittings to hull joint sealants, on the other hand, were damaged. See Image on the right. Need to be re-bedded at next drydocking. Moisture content around this fitting was measured as satisfactory and not higher than in the rest of the hull. See Section 7.1.

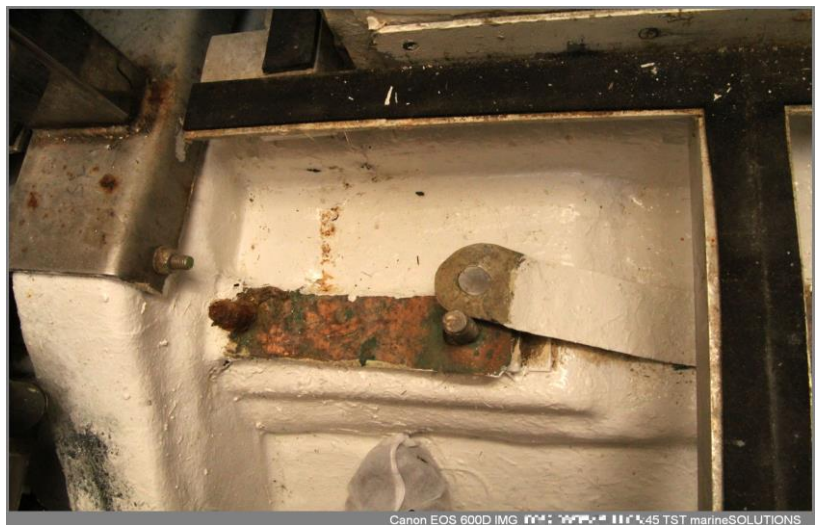
potential of the main engines. The bonding system is in need of attention as some wire diameters are not considered sufficient and as some wires are corroded and/or disconnected. See particularly Section 7.3. Bonding wires should also not be over-painted. Bonding system should be verified.

We have also noted poor connection of bonding copper strips, in particular on both shaft brackets, where the corresponding nuts were missing and the strips had been left unattached. The bonding should be completed and the good conductivity should be verified by a sensitive ohm meter. Reasons, why bracket connections have been left out may shed a light onto the history of the Vessel.

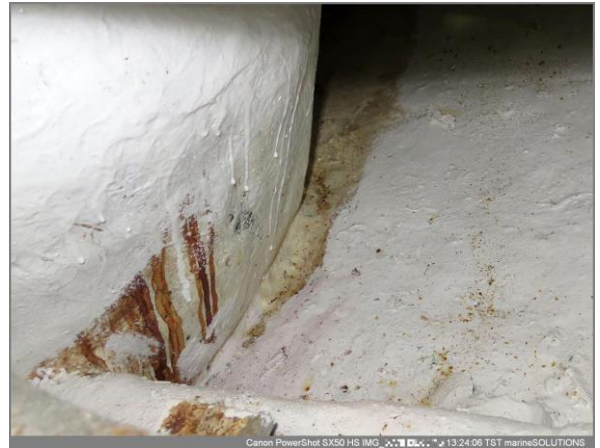
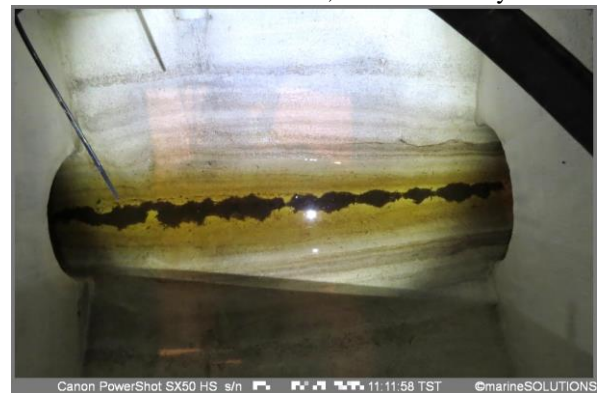
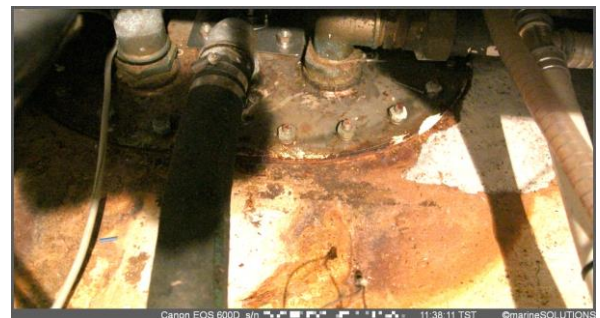
We have noted very recent and hurriedly carried out painting of the bilges. No efforts have been carried out to prepare the bilges for this and indiscriminately rust, oil, salt... has been over-painted. See image to the right. This is believed to have been done to make the bilges look appealing for a very short time during the sale inspections. Such efforts do more harm than good as they cover important tell-tales.

Multiple tide marks and water at time of inspection noted. Source to be determined and eliminated.

Early spill from grey water tank's inspection hole was noted. Spill had severely corroded tank top and may have damaged a sensor. See Section 11.6.3

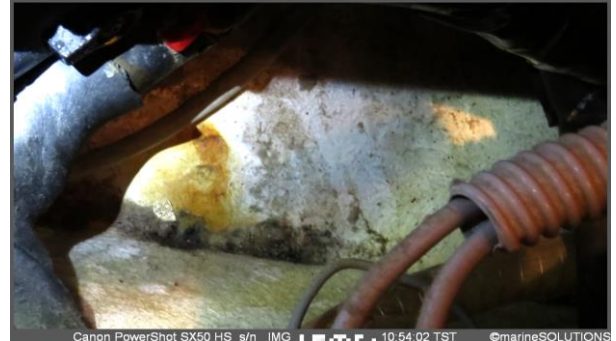
Limited areas could be inspected. Prior to seatrial, noted as reasonably clean and dry. After sea trial some minor leak of the starboard shaft seal noted. See also Section 19. Some oily water noted after sea trial under both main engines as well. Believed to be condensate of main engine intercoolers.

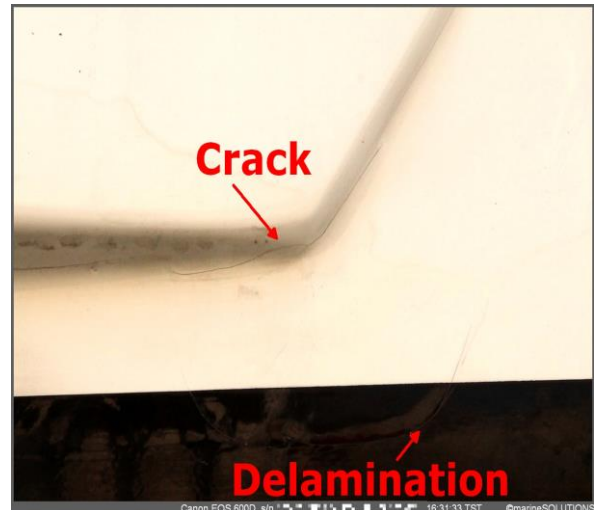
Starboard side exhaust box.

Delamination and cracks at leading edges of both exhaust boxes noted. Issue should be kept under observation and should be repaired if they increase. There are two minor, poor quality repairs on the aft starboard over waterline exhaust box. Consideration should be given to address them in proper manner at some future time.

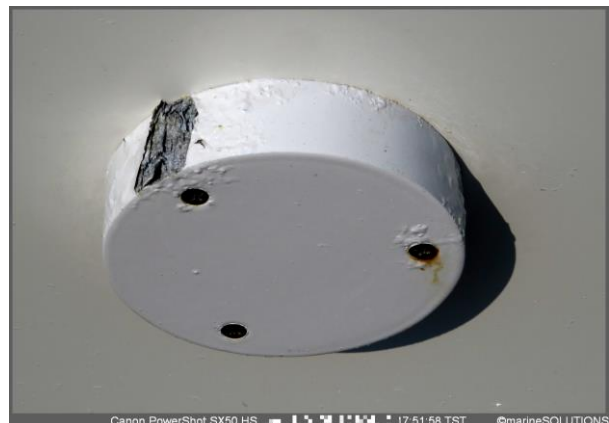
Condition of arbitrary aluminium tank vent

Most aluminium tank vents on topsides were corroded and should be replaced in not too distant future.

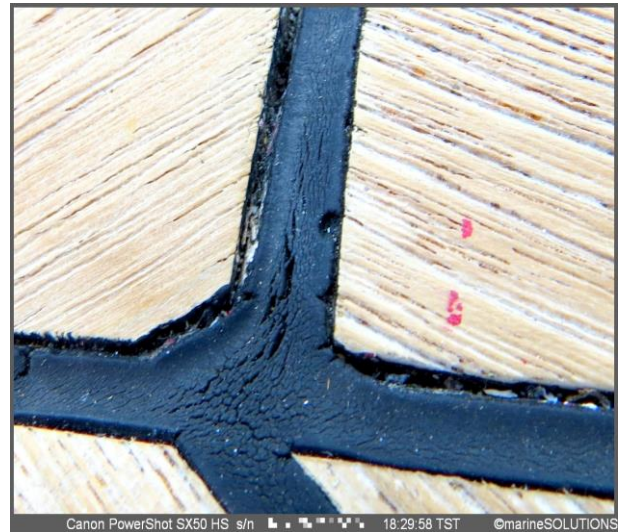
We noted that some seams were detached from teak planks in particular in the forward cockpit, together with some damages to the seam mastic. The main deck needs to be inspected carefully and necessary seam repairs should be carried out.

We noted an approx. 40mm crack on the teak plank adjacent to the starboard side hinge of forward cockpit hatch.

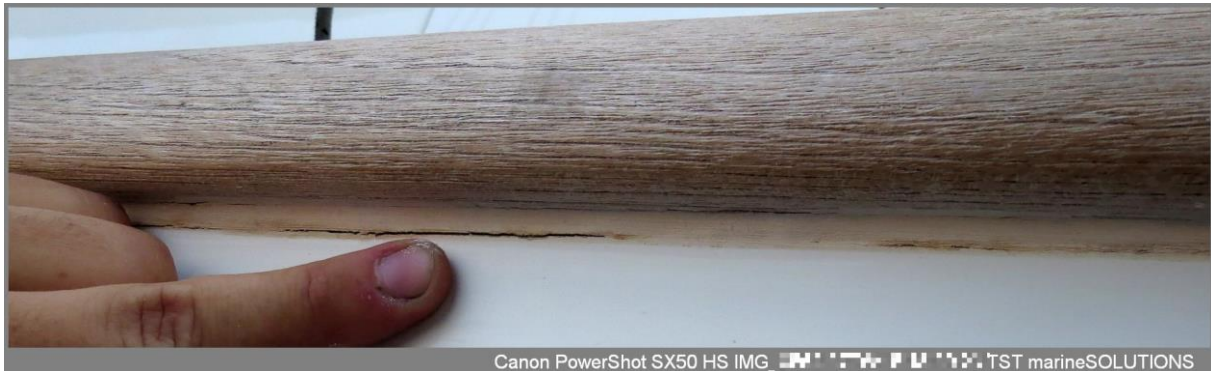
Image above: **Smudgy and parting sealant under capping rail**

Capping rail design and joining was such that scarphs and fitted end caps had moved in spite of good quality teak. Regluing the scarphs could be considered.

The white sealing under the capping rail and sealing the capping rail and hull was smudgy. Need to be replaced with suitable sealant.

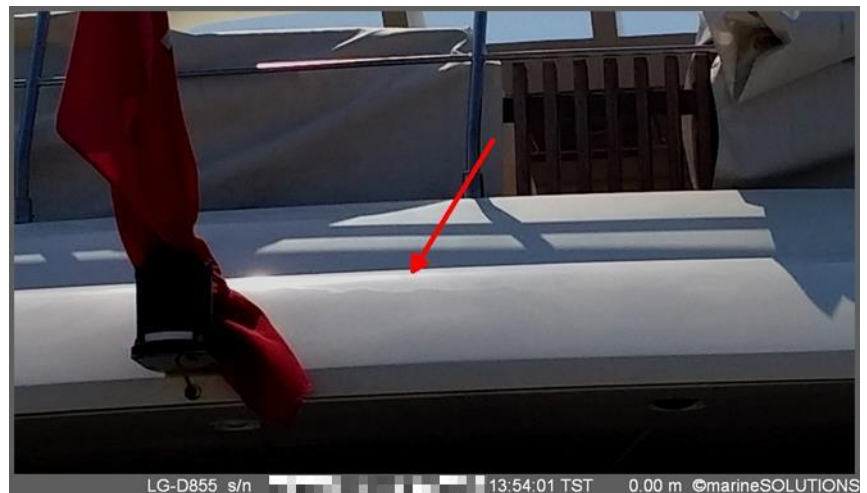
7.17.2 Repairs

Gelcoat repair, likely from fabrication, on superstructure roof aft end vertical finishing over transom, next to flagstaff and mainly to starboard. Visible only in certain, limited light conditions.

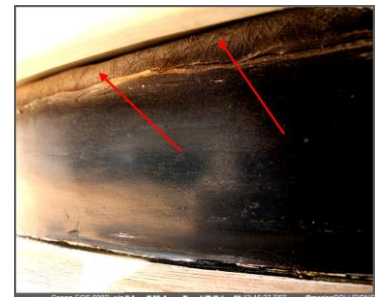
7.17.3 Superstructure Pedestal

Superstructure to deck joint. Raw GRP, delamination and hollow sounding area in forward curvatures of this pedestal. Re-lamination may be considered.

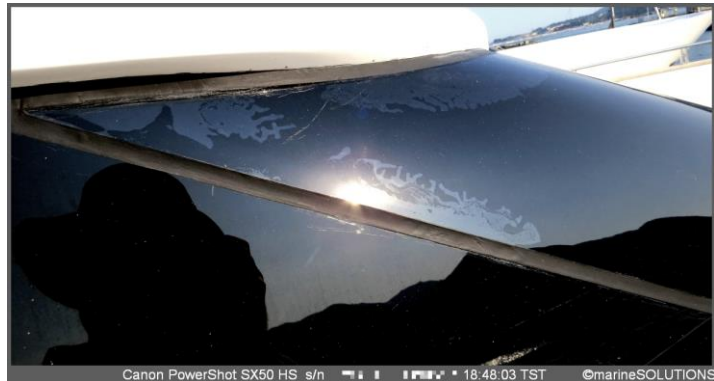
7.17.4 Master Cabin Windshield

Covered with black mesh cover with some missing press-studs. To be serviced.

We noted delamination of the laminated glass on the starboard side and some scratches, likely due to tooling. Recommended to live with it.

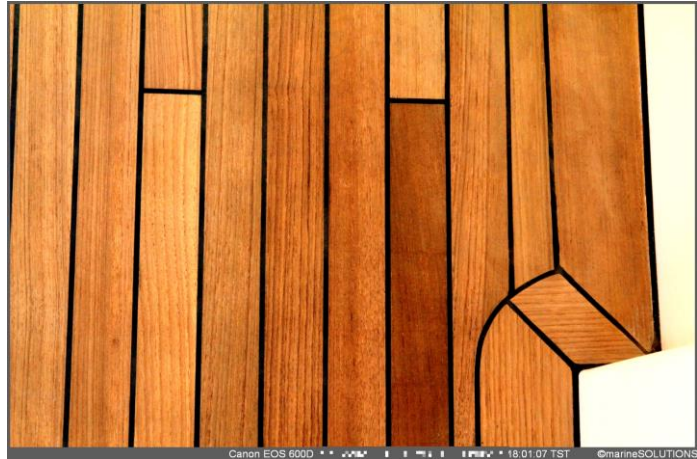
Teak deck is of entirely different and inferior build in comparison to the main teak deck. See Section 7.9. The flybridge deck is made of timber with incoherent grain and cut, seals have given way visibly and extensively (at least 20%) and around margin boards in particular. Teak deck had been sanded just prior to inspection and dust was still well visible at places. Consideration should be given to reseal, repair, replace planks, or best to have the entire flybridge deck renewed.

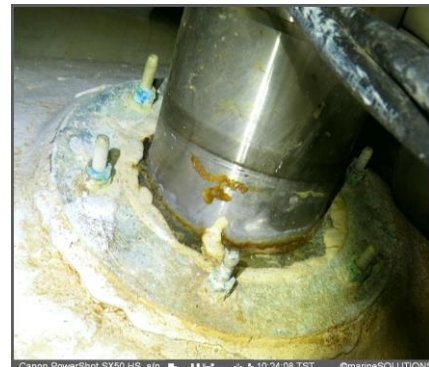
Starboard rudder tube lower flange

Emergency steering system oil level needs to be checked

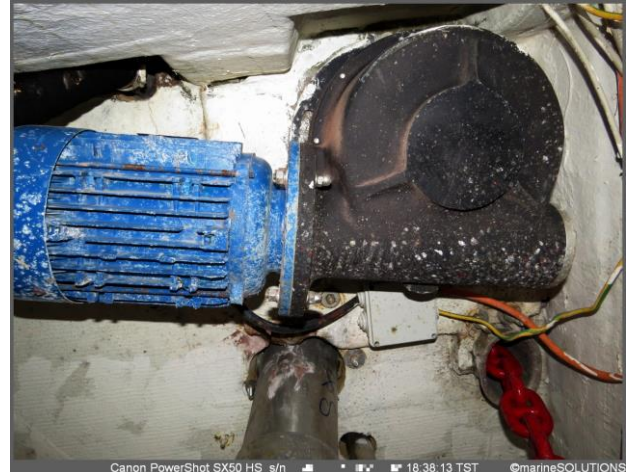
However, under load some slippage was noted, which required retightening of the clutch over and over again. One time the chain of the port side rattled over the gypsy but reengaged after some metres again. Units should be serviced. Gypsy wear should be verified, gypsy should be improved/ replaced.

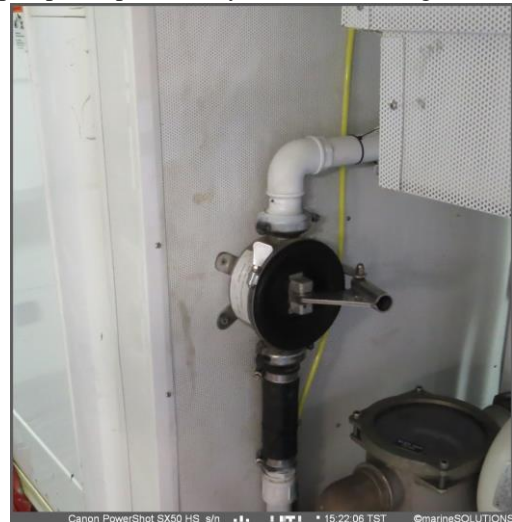
Both main engine raw water intakes are designed to be fed from the bilges. System is suitable to deal with major emergencies like large apertures to hull. Port valve operational, for the starboard valve the handle is missing. To be repaired/ replaced. Safety issue.

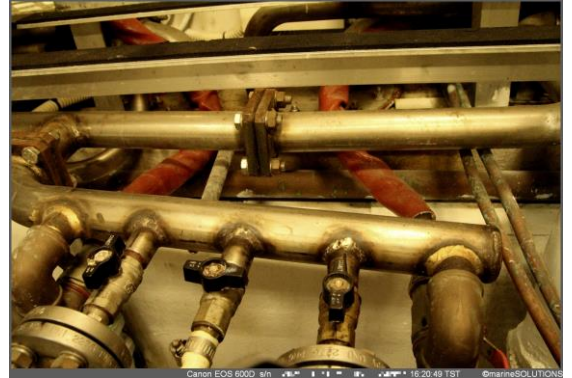
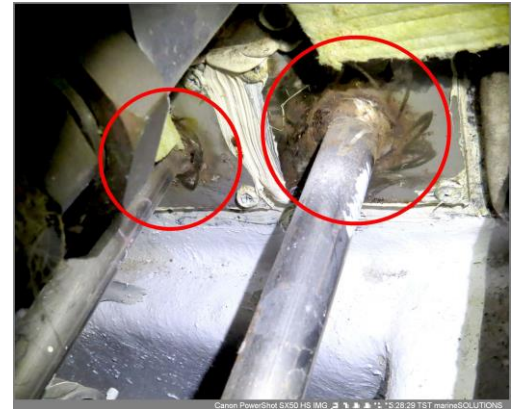
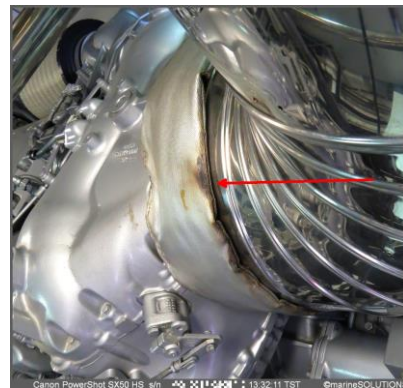
Both main engine exhaust cowls had been built/ were repaired in irregular manner – in contrast to the rest of the hull. See also remarks in Section 7.1.2.

Traces of exhaust line starboard gas leak

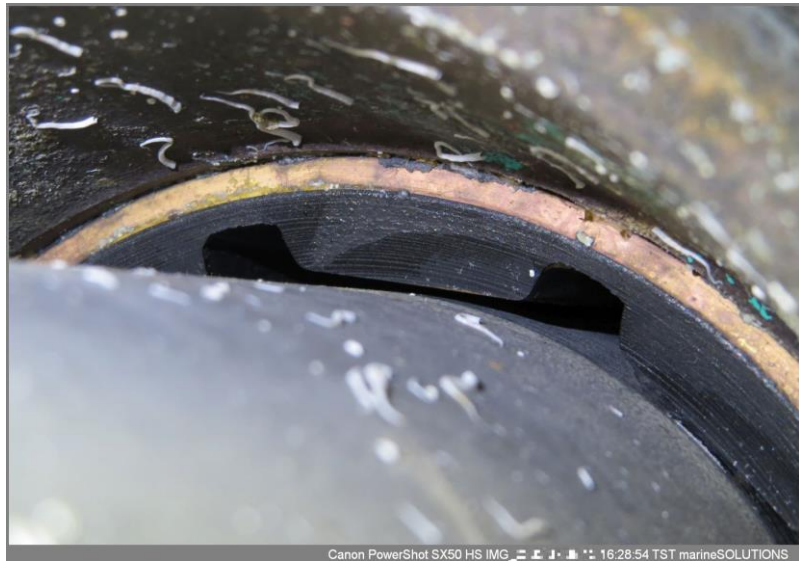
Surveyors noting unusual thin metal tube of the outer shaft bearings estimate the outer diameter of the bearings as about $D_1 = 135$ mm. D_1 for 115 mm bearings is, however, regular about 145 mm and 135 is a regular size for $D = 110$ mm shafts.

This makes Surveyors suspect whether a replacement of shafts has taken place in the history of the Vessel.

Shaft to outer cutlass bearing clearance appears slightly above normal. Outer cutlass bearing tubes slightly dezincified. Replacement to be considered at next drydocking.

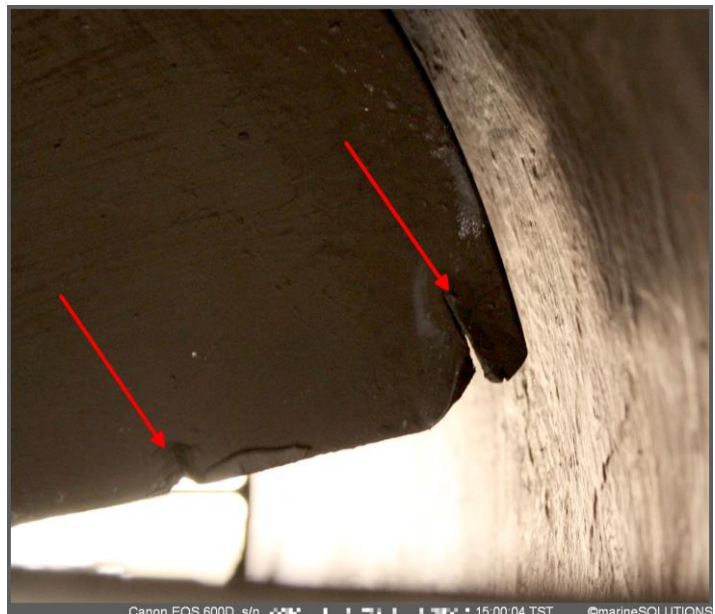
Both bow thruster props fractured progressively. Both propellers to be replaced.

One, particularly battered bow thruster prop blade

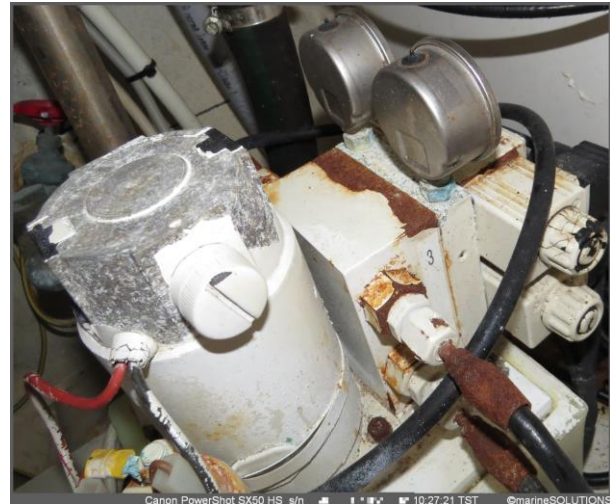
We noted heavy corrosion on the trim tabs hydraulic hose fittings and some corroded areas on the related hydraulic pump unit as well. Whole unit needs to be serviced.

Heavy corrosion on fittings and hydraulic centre.

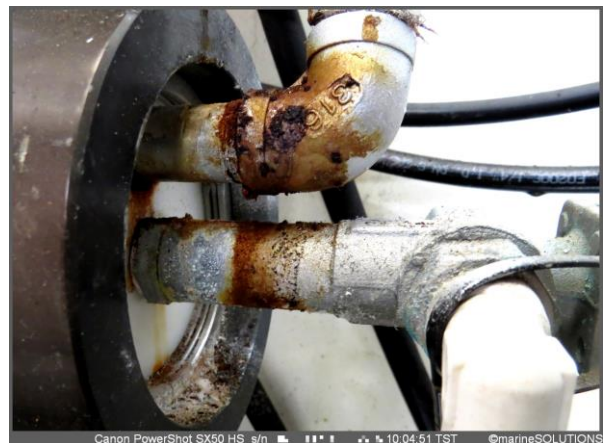
Water maker pan and membrane fittings badly corroded. There were salt residues and corrosion on membrane caps. Low pressure pump mounts were corroded – half-hearted attempts to clean were noted. The whole water maker unit needs to be serviced, preferably on the workshop bench.

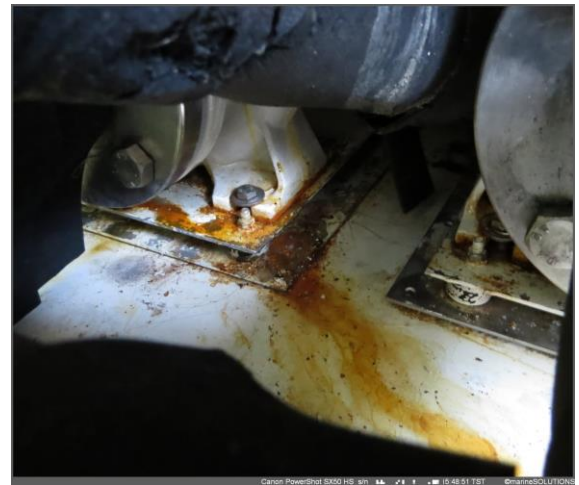
Progressive corrosion on the freshwater pump mounts, chiller unit pans, on the compressors' mounts and on the stainless steel indicators' holding plate was noted. A proper servicing should be carried out but can only be carried out after the units are dismantled.

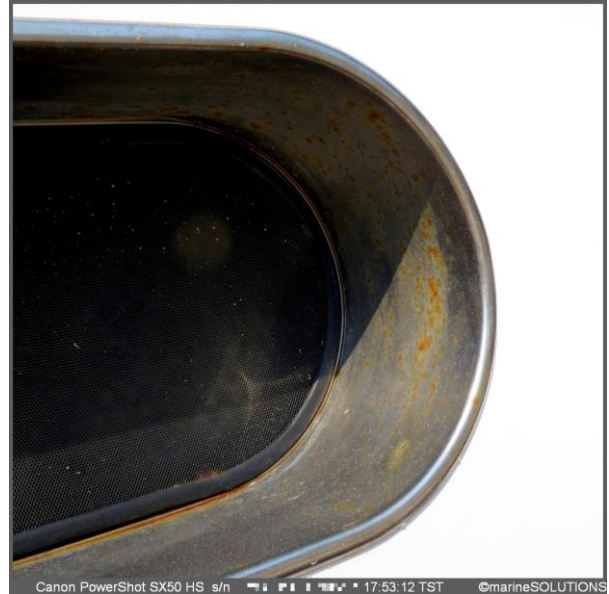
Rust, porthole outer frames

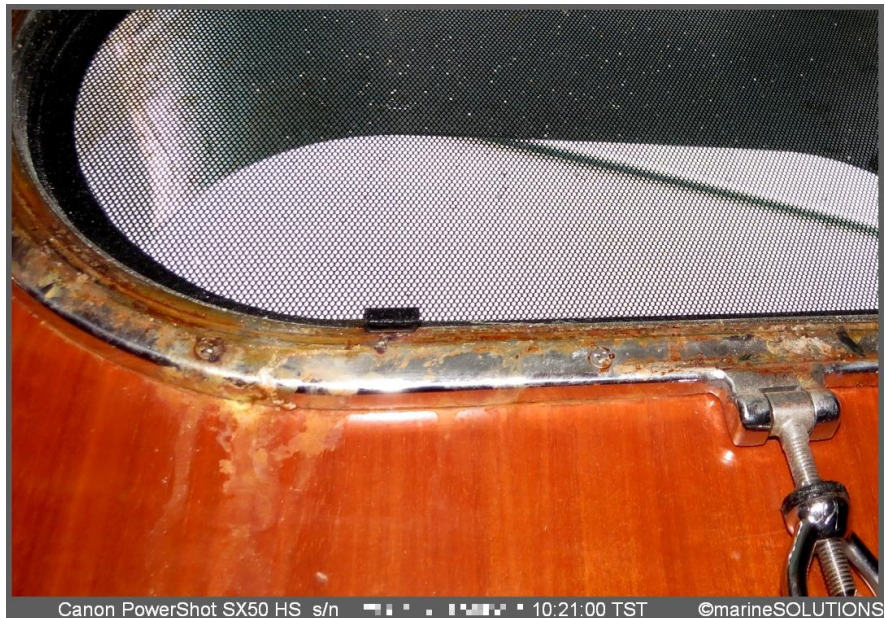
Typical rusting leak from porthole gasket

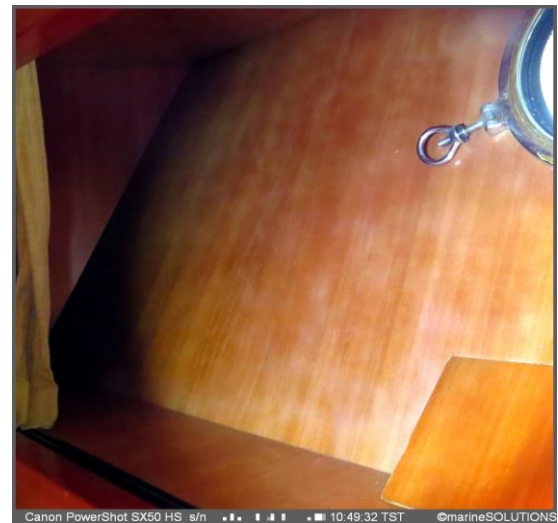
Furthermore, panels and wooden frames showed minor but numerous and disturbing damages throughout the Vessel’s quarters. These were impact damages, where (usually) a small area of $D < 5$ mm had chipped off, and the adjacent varnish had started to lift and had turned opaque. There were also many regular scratches of a few cm length or less. A very few major damages were also noted. Services of a skilled artisan should be secured to retouch carefully and patiently all these areas.

Leopard pattern at side ceiling varnish

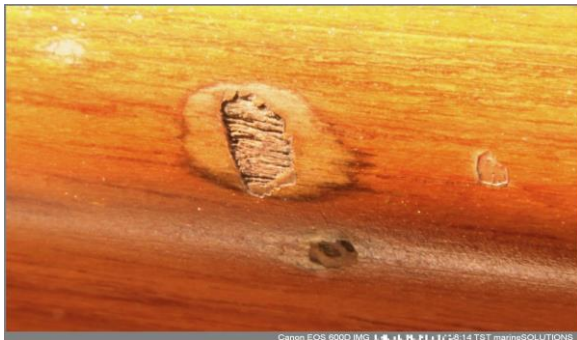
A typical damage with $D \approx 5$ mm

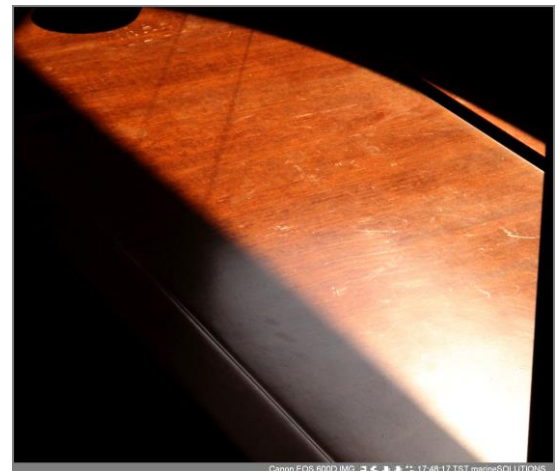
A densely scratched area of the furniture

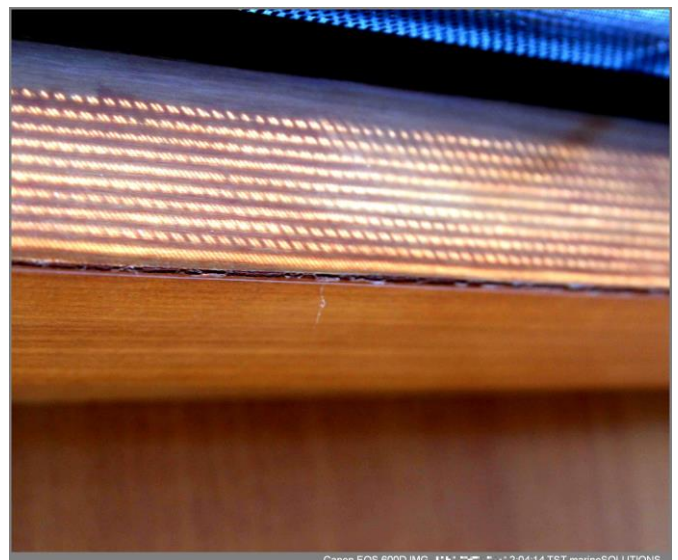
Right: delaminations on the dashboard and on the windscreen joinery
