SHORT - REPORT

Pre-Purchase Condition Survey Short-Report**1 Particulars of the Vessel***Name Of the Vessel* M●●●●●*Port of Hail* London*HIN*

2 Particulars of the Survey*Survey's Scope* Pre-purchase condition survey*Surveyor(s) on Site* Mr. Cem Baykent, BSc.

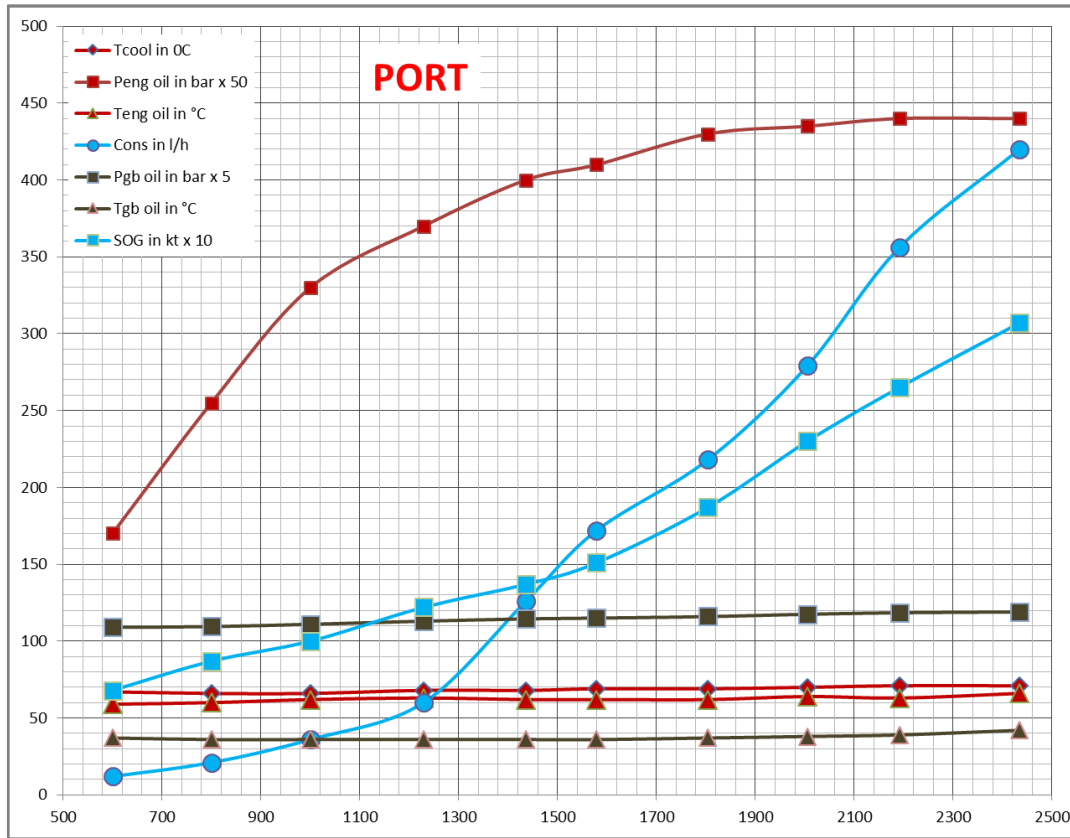
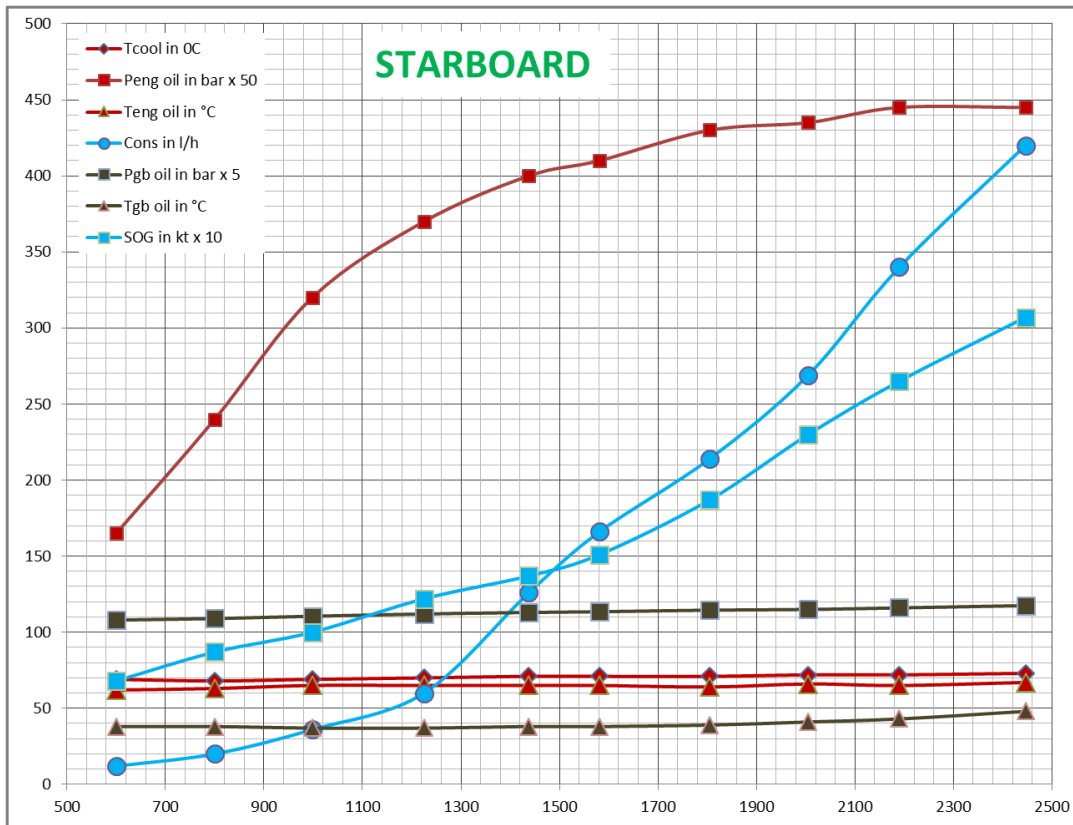
Seatrial data plotted the Port engine (above) and the Starboard engine (below) - in both instances as a function of the respective engine revs. For better visibility, the engine oil pressure, the gearbox oil pressure and the Speed over Ground have been displayed with x50, x5 and x 10 respectively. No inconsistencies or unexpected differences between engines noted.

The manufacturer's published engine parameters have not been studied in detail, however, the behaviour of the engine parameters are considered as predominantly symmetric between engines and as expected. Engine and propulsion performance deemed satisfactory.

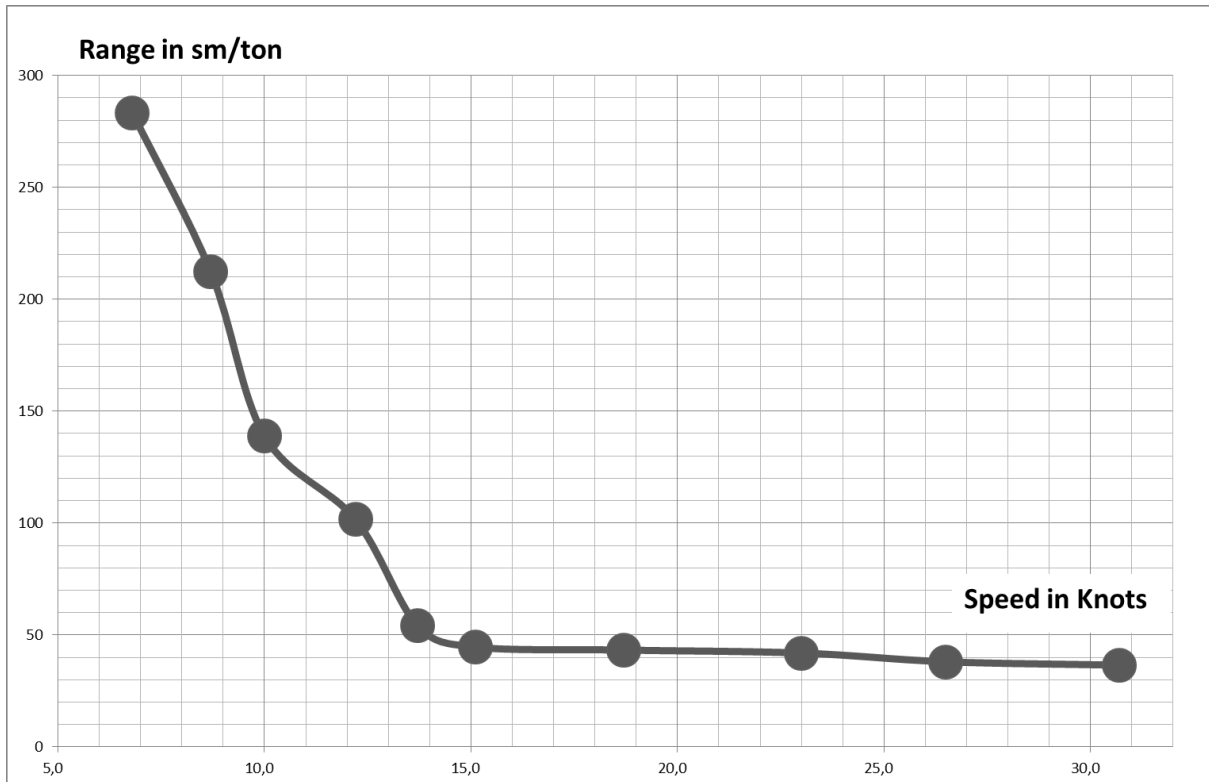
Derived Range (per ton bunker) of Vessel. In the cruising operation range of Vessel about 40 sm/tons is performed.

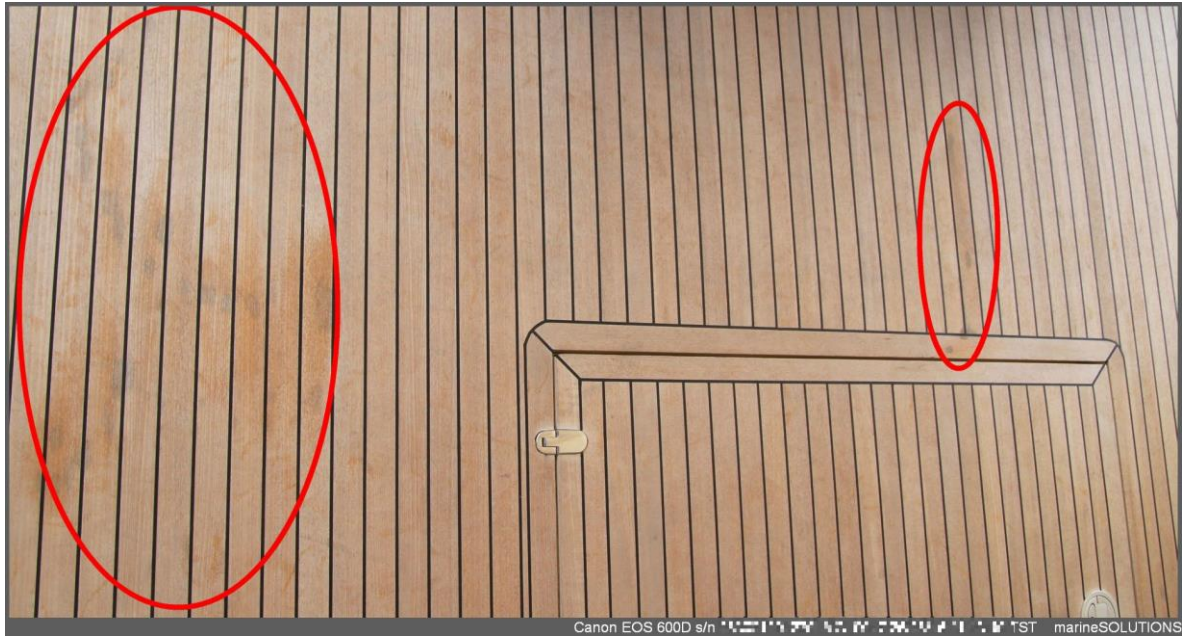
- 10.5 My findings to the cockpit teak deck are as follows:
- 10.5.1 I noted some dark stains on the teak deck of the cockpit, mainly concentrated at the mid-section. There were marks of attempted cleaning to remove the stains, which were not successful. These stains should be removed.

Dark coloured stains on the cockpit teak deck.

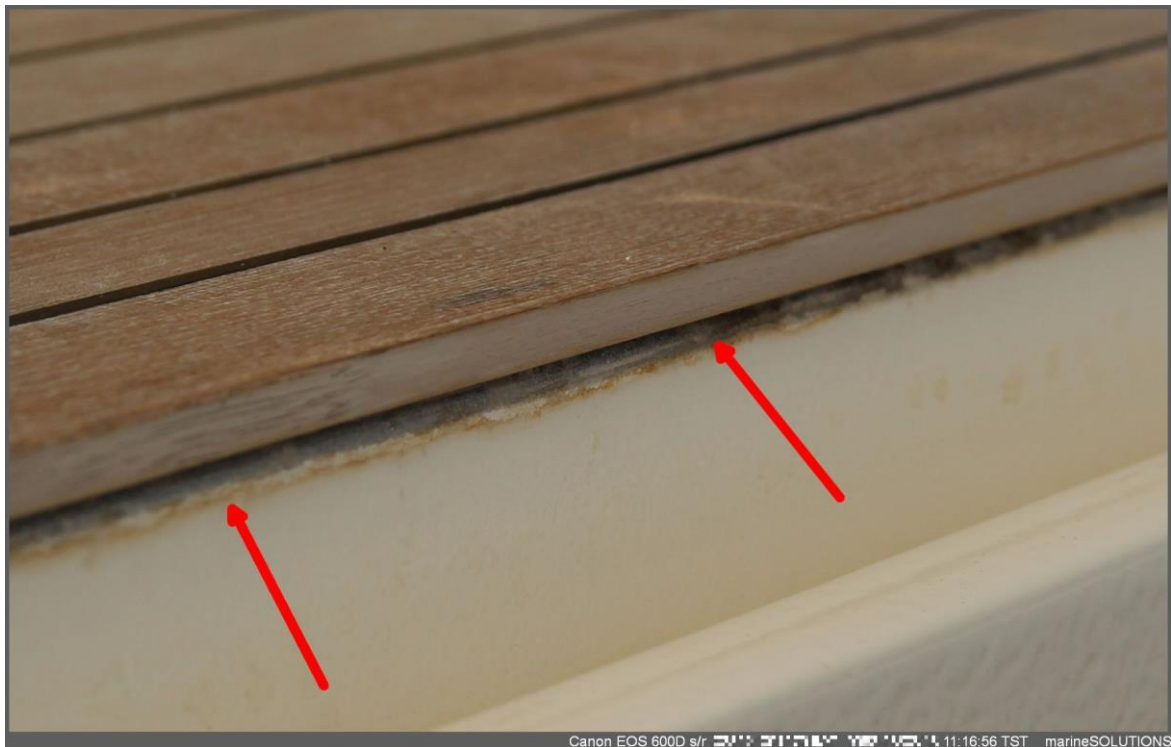
- 10.5.2 I noted a cracked single teak plank to the port side corner of the cockpit deck towards the superstructure corner. The area sounds hollow when tapped. It is highly likely that its underside was not filled properly. This plank needs to be replaced.
- 10.5.3 The underside of the teak frame on the cockpit deck, around the engine room access hatch misses proper adhesive and has a hollow sound when tapped. The plank to the port side of this frame has a longitudinal crack, possibly due to this issue. I recommend to replace the cracked plank and inject proper elastic adhesive to the underside of the remaining frame.

Detached teak plank around the engine room hatch at the cockpit.

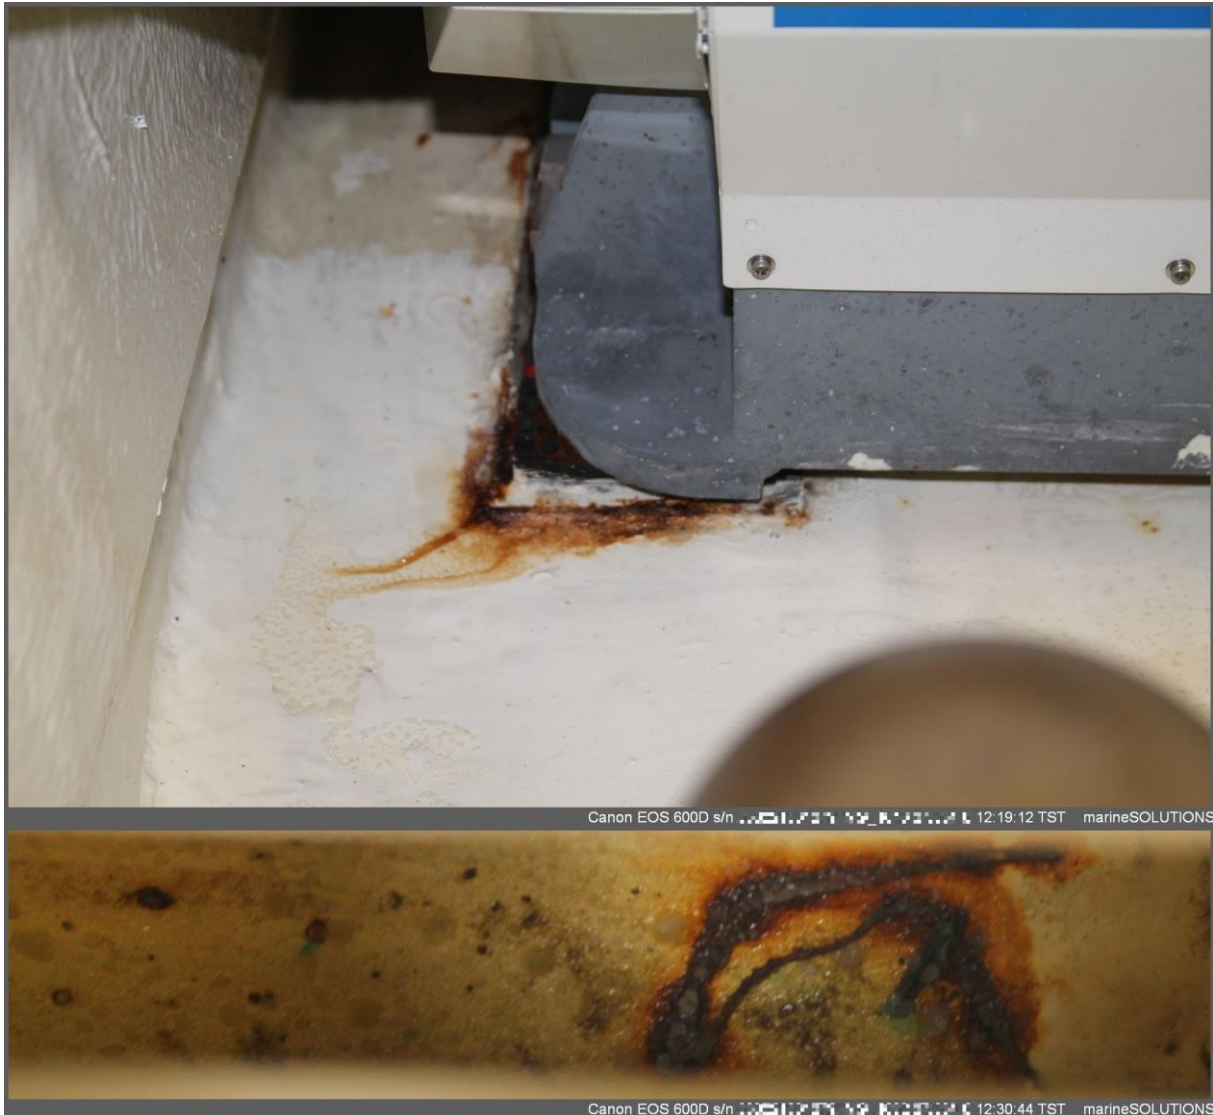
- 10.6 It is reported by the crew that the port side shaft seal had a water leak in the recent past. Both shaft seals had been replaced after this issue. This past water leak caused the nearby components to corrode.
- 10.6.1 The shaft coupling showed surface corrosion. Proper cleaning should be carried out.
- 10.6.2 The bolts of the coupling showed corrosion. They need to be removed one by one, cleaned and reinstalled.
- 10.6.3 The mounts of the ARG (Anti-Rolling Gyro Stabilizers) units show moderate level corrosion. I also noted crystalized sea water salt under the ARG units. Both ARG units should be dismantled, their underside should be cleaned and their mounts should be replaced.

**Top: Corrosion products leaking from one ARG unit's mount.
Below: Salt crystals and a heavily corroded metal part located in between both ARG units.**

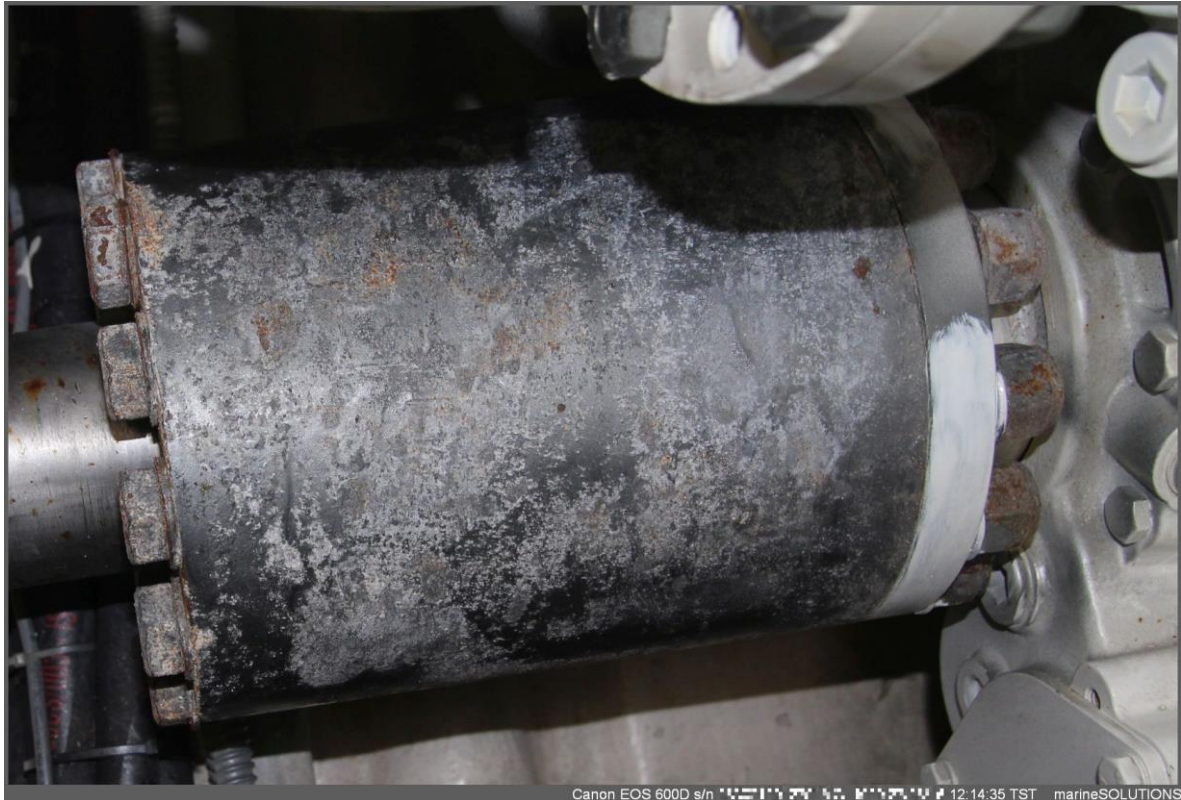
Surface corrosion of the port shaft coupling and its bolts.

10.6.4 Some corroded nearby components should also be attended.

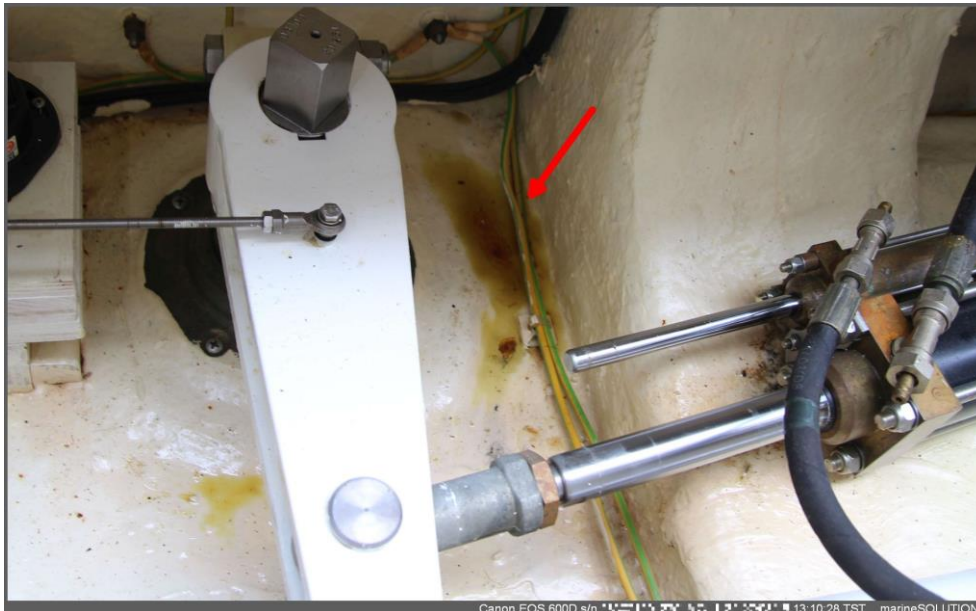
10.7 I noted traces of oil leaks under the starboard rudder arm. The Captain cleaned the leaks prior to the sea trial. After the sea trial, I checked the area once more and noted oil residues again. The leak seems to be from the steering system. The leak should be traced and cured as soon as possible.

Oil leak traces at the starboard side rudder arm.

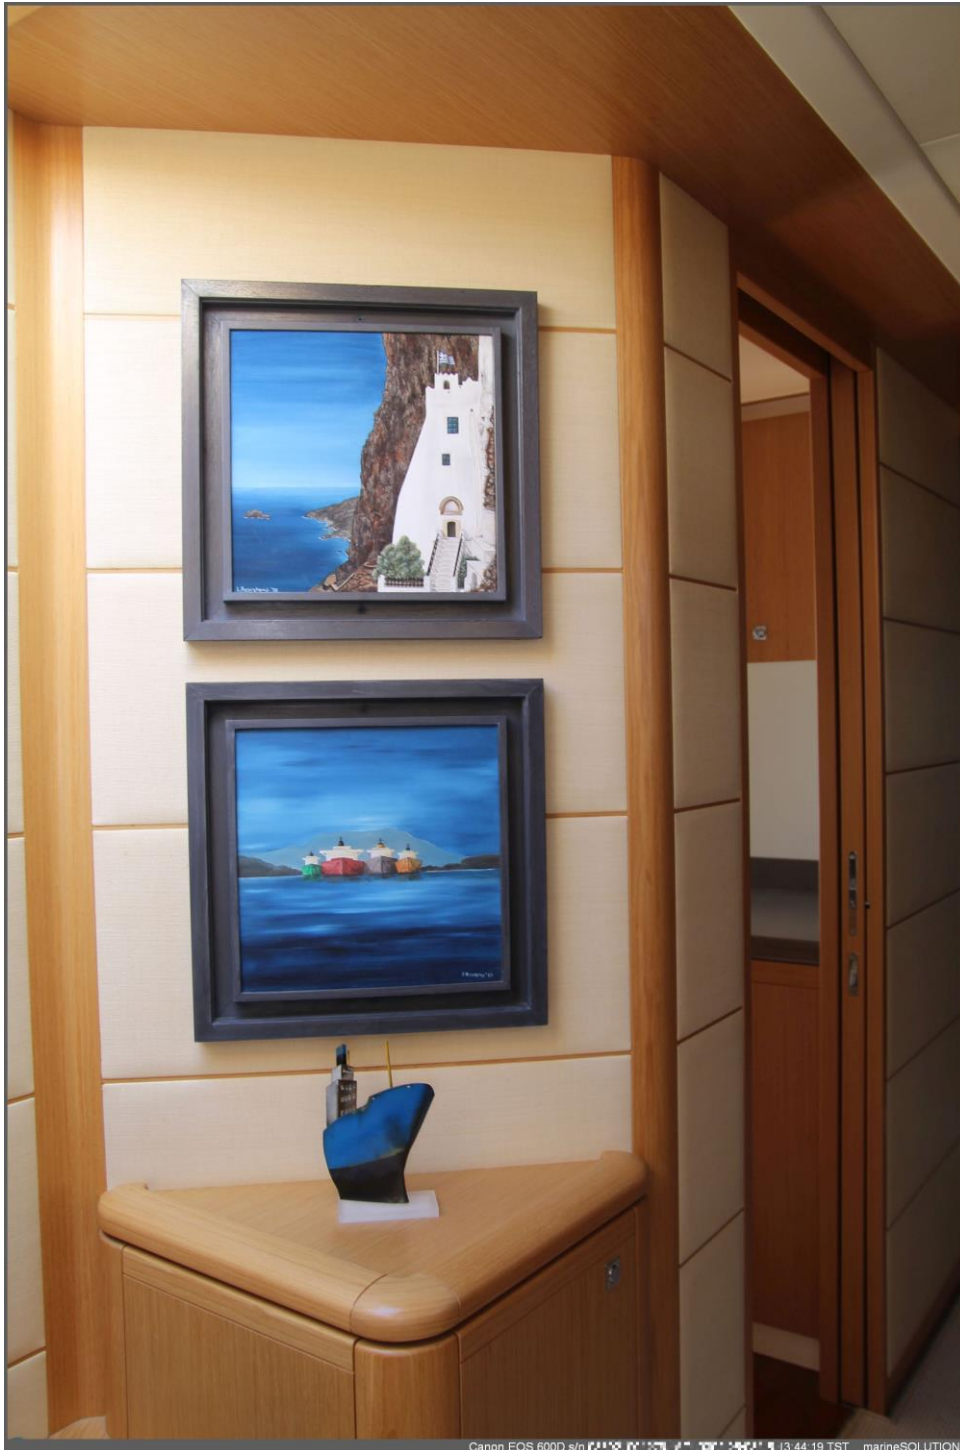
- 10.8 The Vessel's present Owner shows interest in art. There are a number paintings, art and religious figures around the Vessel, mostly located at highly visible areas. It is reported that they are not a part of the Vessel's inventory and will be taken away once the Vessel is sold.

Their removal brings up two issues. The wall panels/linings and furniture tops may be damaged during their removal. Also, the panels, so far having been covered by them are highly likely aged differently from their surroundings so this will make their place visible once removed. The remedy for this issue may be demanding. This issue needs to be sorted out between the parties in a fair way.

Sample of art figures from the Vessel at a high visible area.

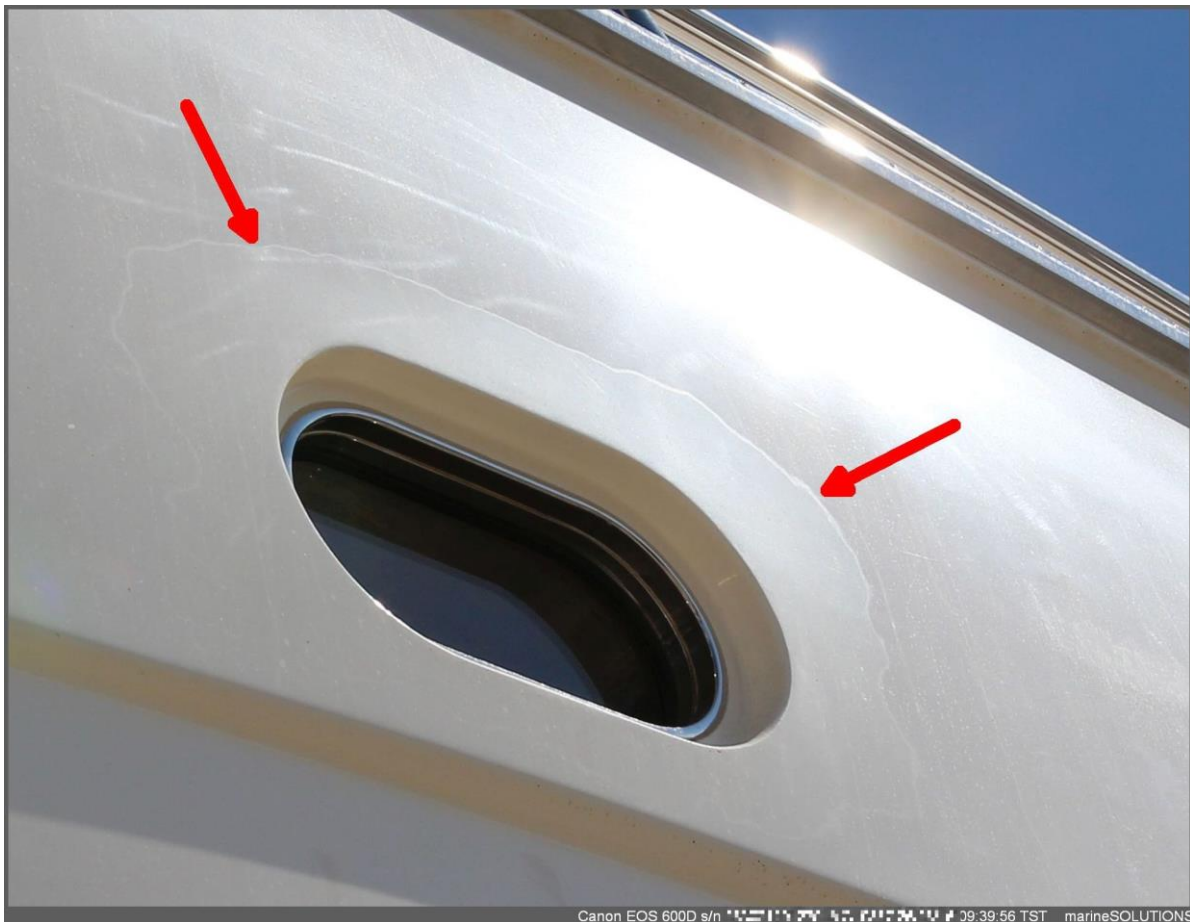
11.1.2 There are visible transition lines which look like separating gelcoat repairs. The captain reported that he was on board since the Vessel was launched and clearly declared that the Vessel had not been a part of an incident or whatsoever during her life.

I am in the opinion that according to their shapes, locations and surface condition these irregularities are highly likely due to the manufacturing process and will get visible due to the ageing of gelcoat.

Transition marks around one of the portholes – photo not altered.

The hull needs to be polished properly.

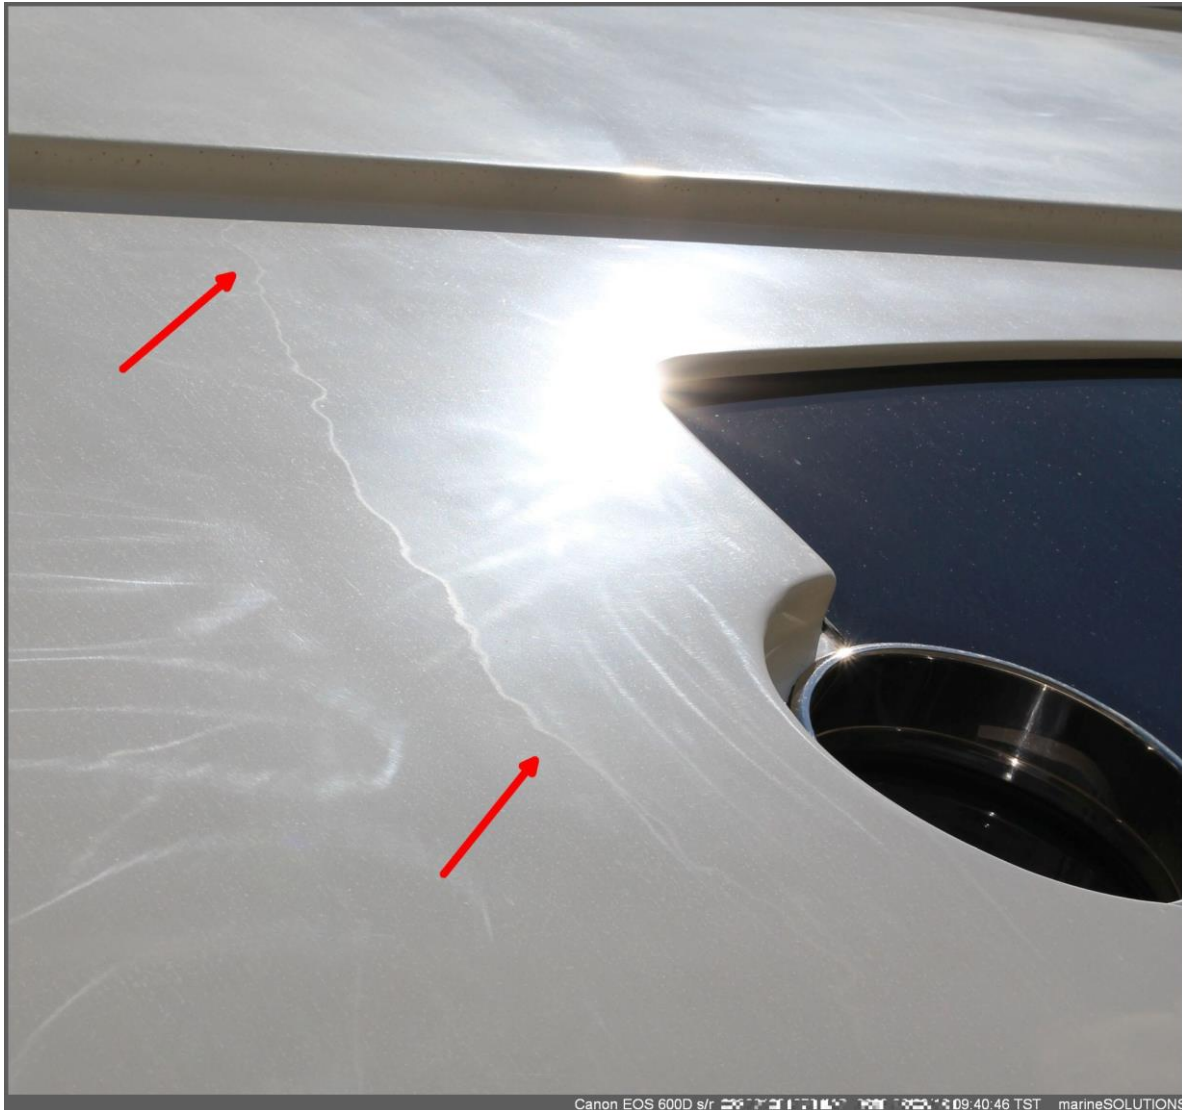
Transition mark around the port master cabin window – photo not altered.

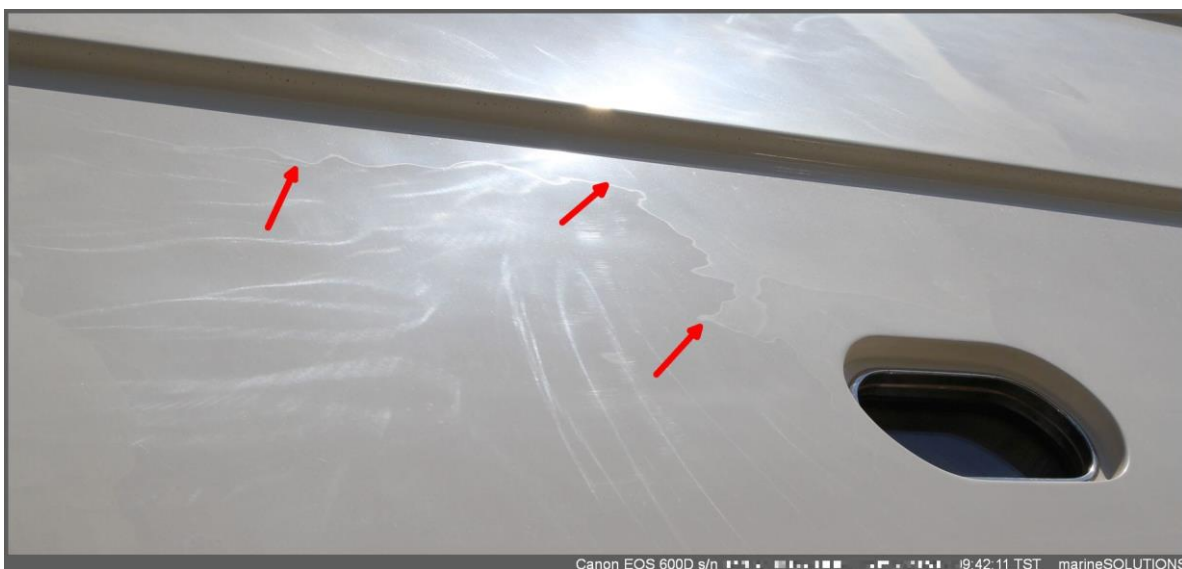
Another sample of transition marks – photo not altered.

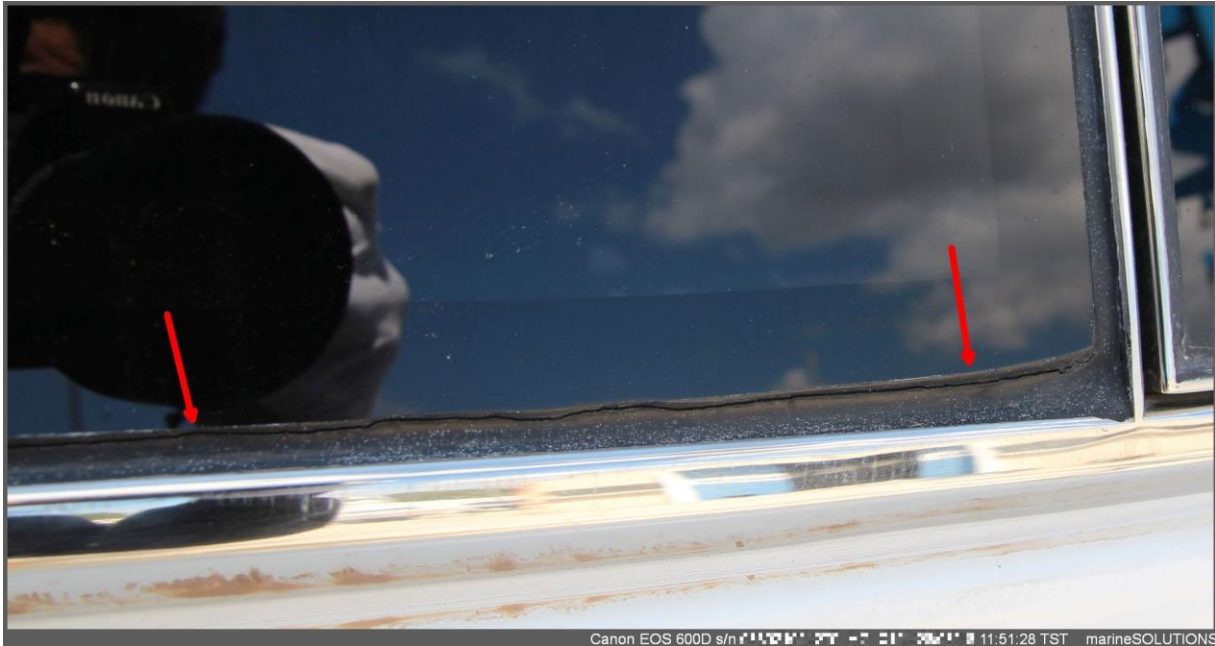
- 11.2 I noted non-structural stress cracks not longer than approx. 10 cm on the gelcoat at both corners of side window frames to the fore of side doors. These needs to be repaired properly.
- 11.3 The mastic on the lower section of the starboard side window had been detached , located ahead of the side door. The mastic should be renewed.

Detachment at the starboard side window mastic.

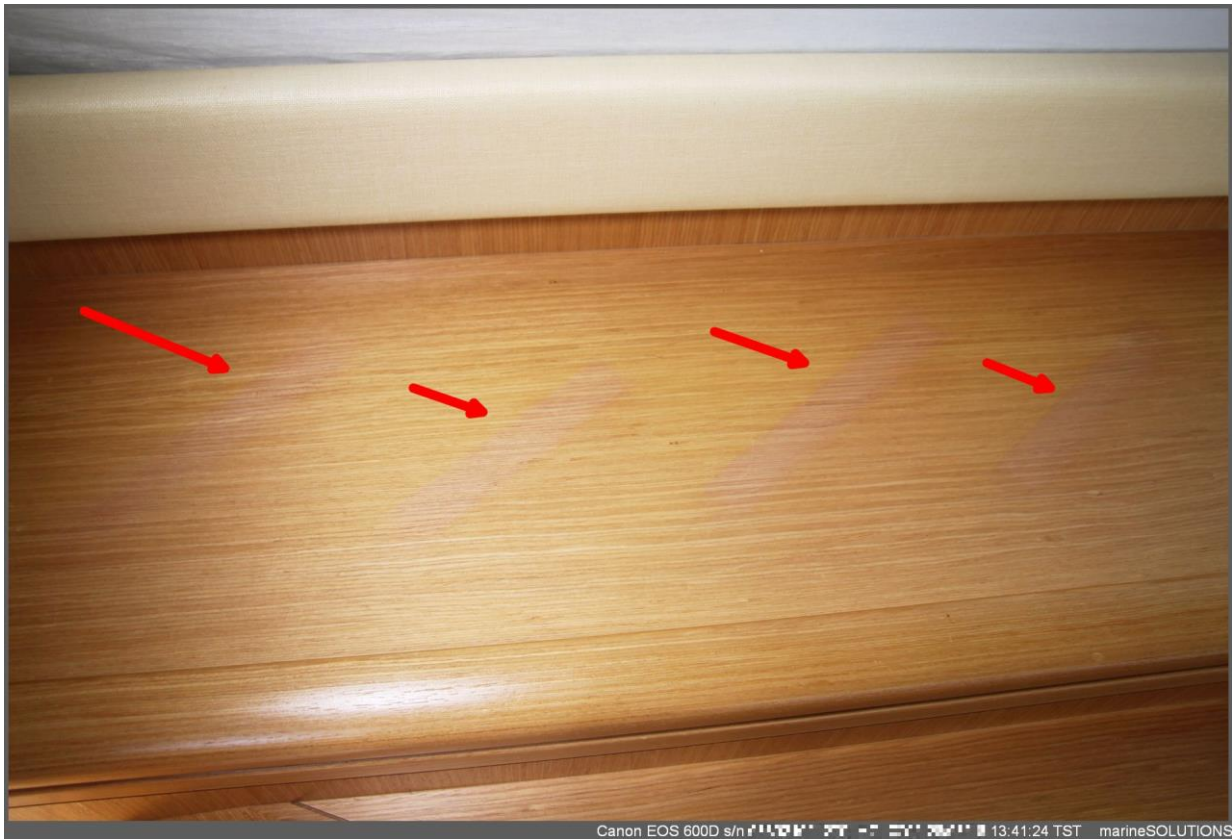
- 11.18 A few pushbuttons at the Vessel were not operational and need to be replaced.
- 11.19 There are wooden counters at both sides of the dinette area. I noted four marks on each counter top. It is reported that there were standing frames at those locations for a long time. Due to that, the varnish aged differently and caused the noted marks. I don't recommend taking any action on this issue but accept it as there is a risk of ruining the varnishes. The varnish color may come close to a match over time.

Four frame marks on the counter top at the side of the dinette area.

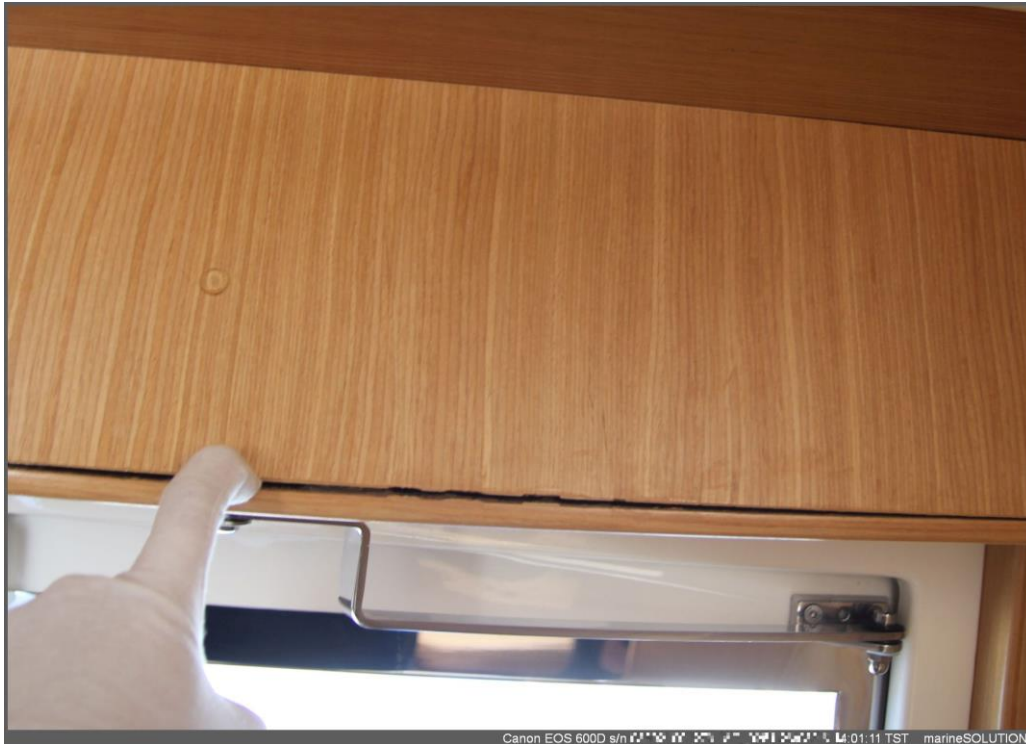
11.20 The lower side of the electric motor housing panel of the starboard side door needs to be re-sealed.

Gap needs to be resealed covering the starboard side door motor.

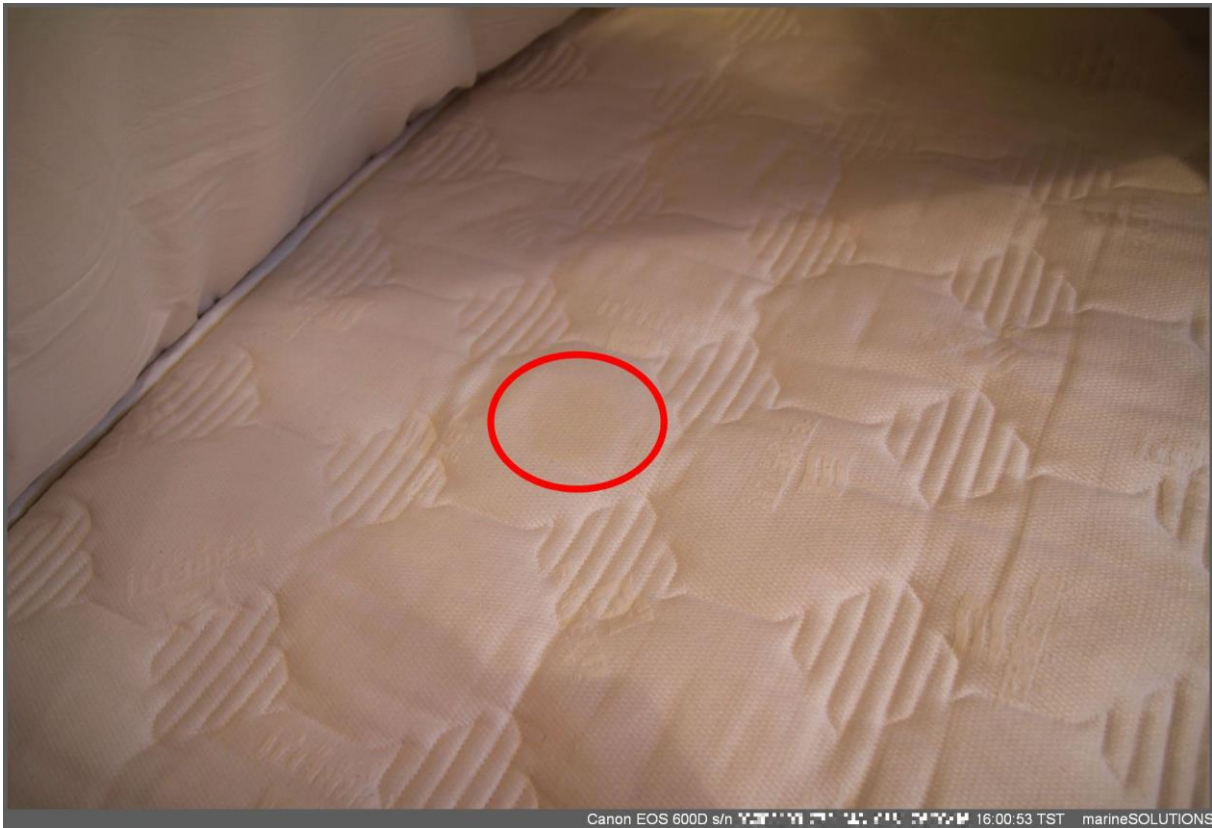
11.30 I checked all the cabin bed mattresses. The bed mattress located to the corridor side of the starboard cabin had a stain of approx. 10 cm in diameter at its middle. The stain was limited to one side of the mattress. The remaining mattresses were free from any stains whatsoever.

Stain at the starboard side cabin bed mattress.
