REPORT

Pre-Purchase Condition Survey Short-Report**1 Particulars of the Vessel***Name Of the Vessel* s/y A●●●●●●●● I●*Flag* Denmark*Port of Hail* H●●●●●●k*Documents To The Vessel* n/a. See Section 7*HIN*

*Manufacturer* Conyplex BV*Type* Sailing Yacht 48CS*Date of Manufacture* 20●●*Length oA¹* 14,83 m*Draft* 1,89 m.*B_{max}* 4,25 m.*Material hull, deck, superstructure* FRP*CE Plate*

**2 Particulars of the Survey***Survey's Scope* Pre-purchase condition survey with short report of deficiencies only*Surveyor(s) on Site* Mr. Tufan Tunalı, Naval Architect and Marine Engineer*Date, Time and Place of Survey* 28. ●●.20●●, 08:45 – 22:10, ●●●●●●●●, Denmark*Met Conditions during the Survey* Rainy at times and fresh breeze*Those Present during Survey* Mr. P●●●● M●●●●●●●● (the Owner) and Mr. H●●●● P●●●● (from the Brokerage)*Afloat/ On Hard* Both*Instructor* Mr. J●●●● S●●●●●●●●**(For the Surveyors' Opinion please see Section 18 below.)**¹ All dimensions are taken from the owner's manual of the Vessel.

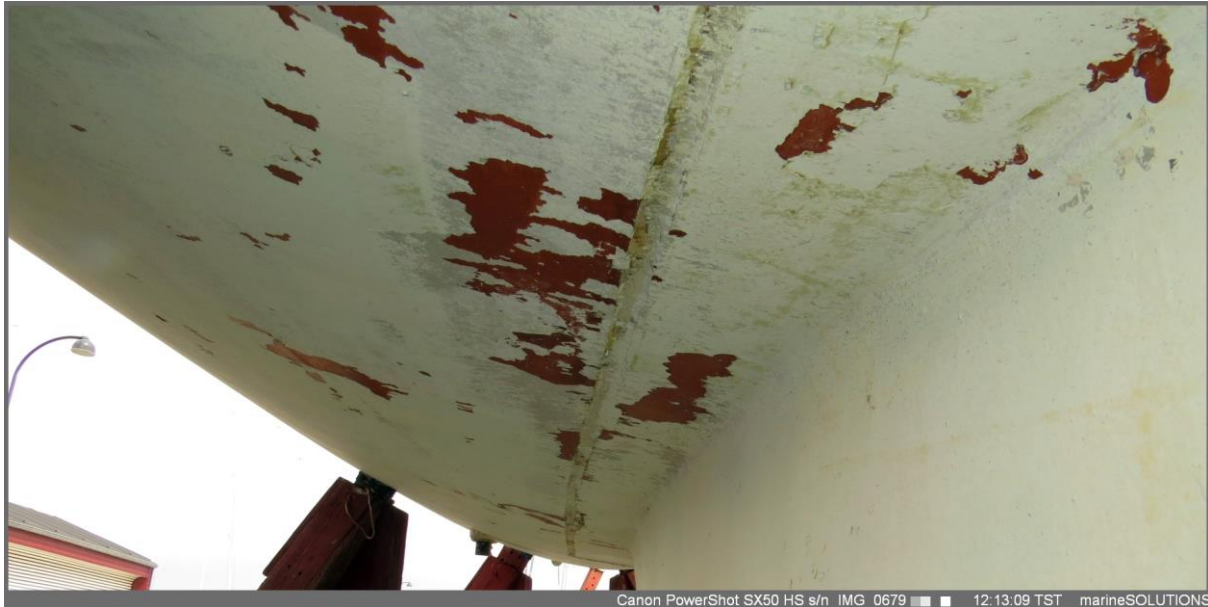
Generally, I was satisfied by the visual impression. In some sections the antifouling paint was flaked off and the layer underneath was visible. These areas need to be coated with proper underwater hull systems.

Above: Flaked off (red) areas on the submerged hull and the layer underneath of present antifouling.

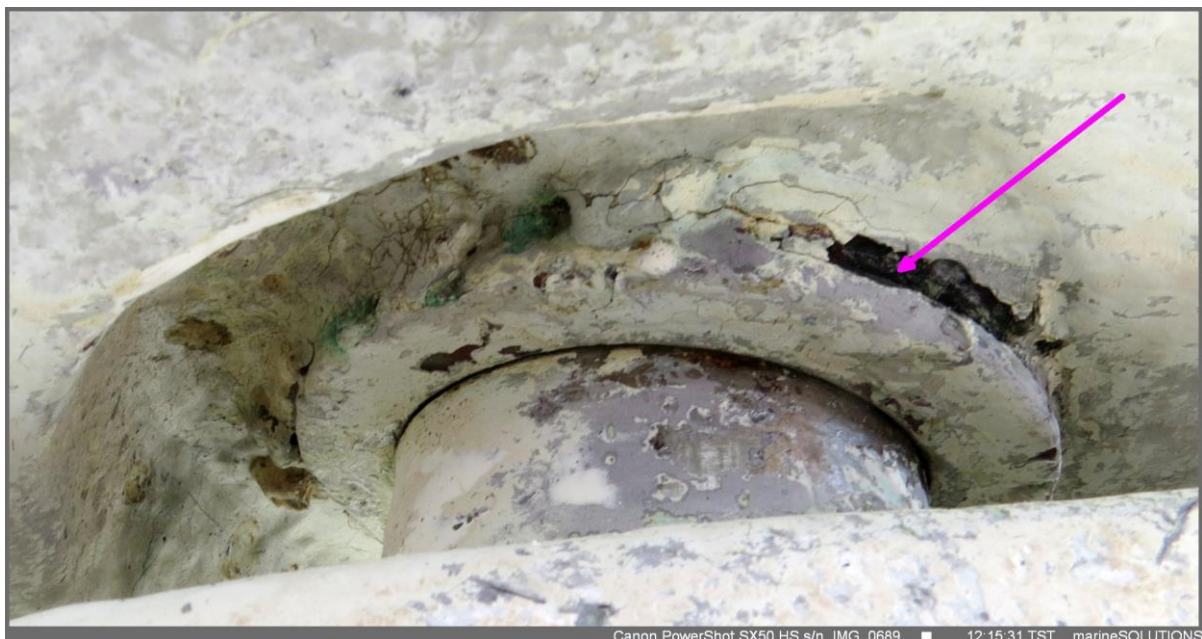
The sealant around the rudder shaft's lower bearing installed as thru-hull had started to deteriorate. Furthermore, the clearance between rudder shaft and the bearing is considered to be above acceptable limits. No leaks from the shaft to inside were noted. It would be beneficial to service/replace the rudder shaft bearing and apply new sealant at some next opportunity.

Above: Deteriorated sealant around the rudder shaft's lower bearing

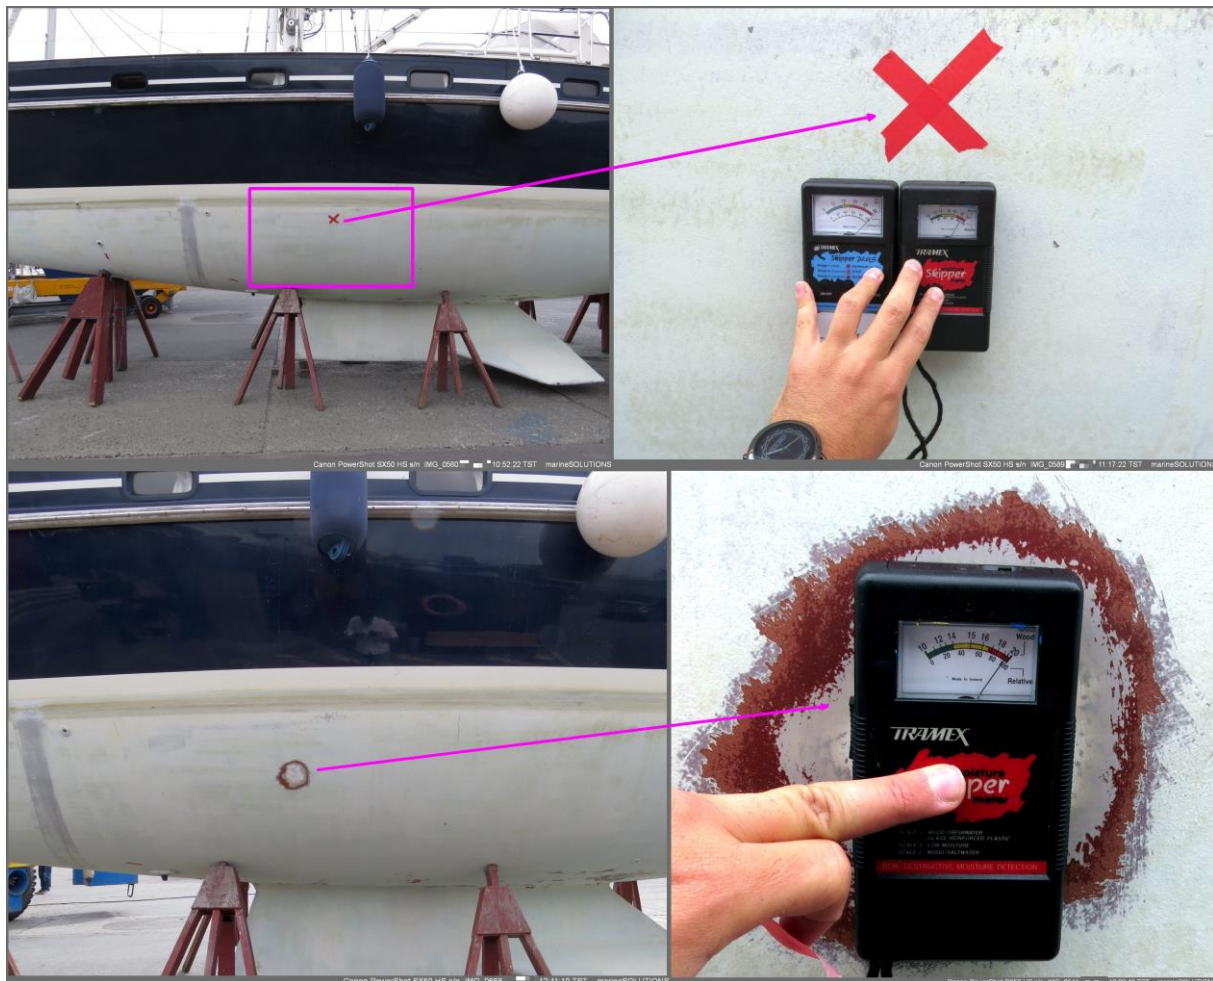
I noted two high moisture areas of approx. D=30 cm and one rather large area of approx. 150 cm x 120 cm. One of the smaller areas is located on the port side of the sonar transducer and the other is located on the starboard side of the cockpit's starboard aft drainage. The rather large area is located at port amidships.

First, I inspected the corresponding areas from inside and cross verified the high moisture. Then, I asked to scrape off the layers up to the gelcoat surface on the port amidship and the area around the cockpit's drainage. I retested these two scraped areas and the moisture content was still the same, above acceptable limits.

Above top left: **The high moisture read area in magenta rectangular.** Above top right: **Moisture content determination with two devices.**

Above bottom left: **The scraped back area on the port side of the submerged hull at amidships.** Above bottom right: **The moisture content after the layers scraped back to gelcoat surface at port side of the submerged hull.**

The high moisture read areas need to be dried and treated with proper treatment methodology. This is a serious issue that should be clarified preferably before purchase. On the other hand, history of submerged hull treatment might impact the Vessel's value in the future. The relatively limited treatment should be well documented.

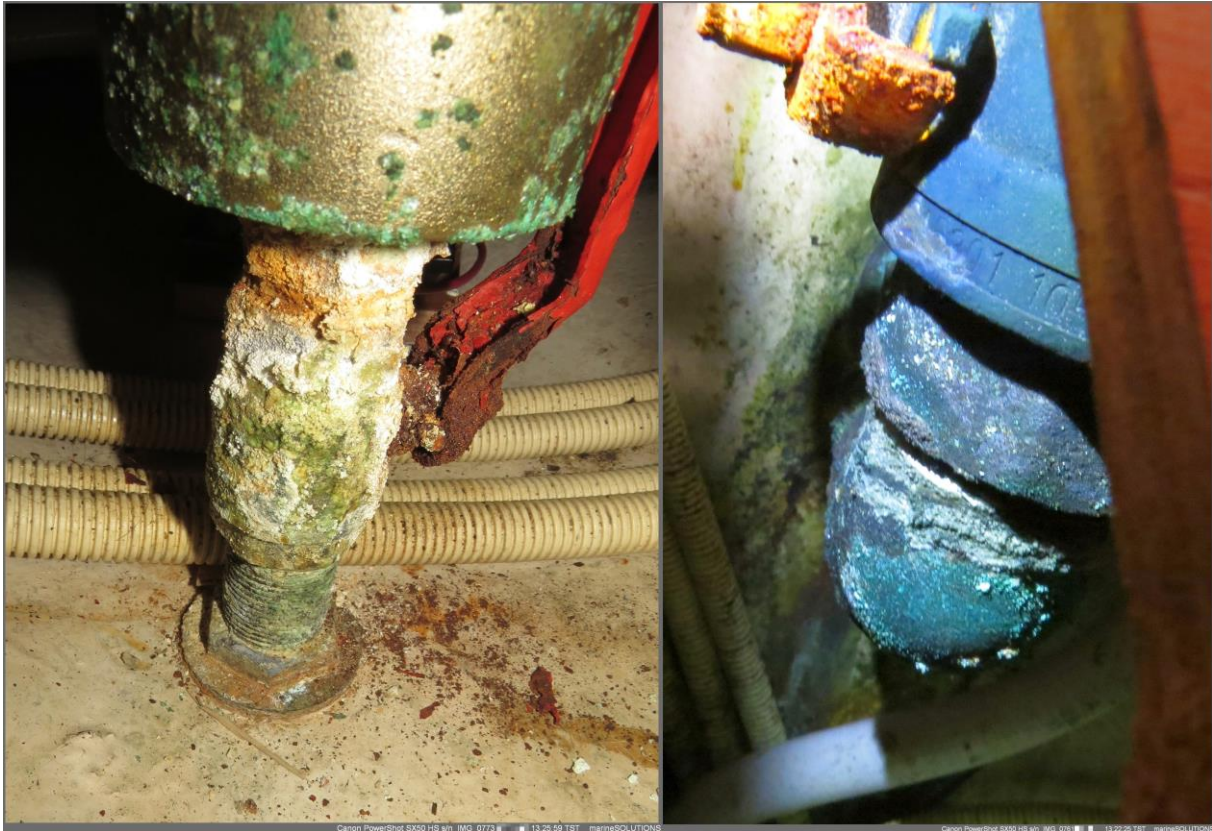
- 10.1 Almost all the seacocks have corroded. Some of them, such as the forward toilet's discharge seacock, the water maker's seawater inlet seacock, etc. were heavily corroded. All of them need to be checked, maintained and replaced if necessary.

Above: Examples to the corroded seacocks

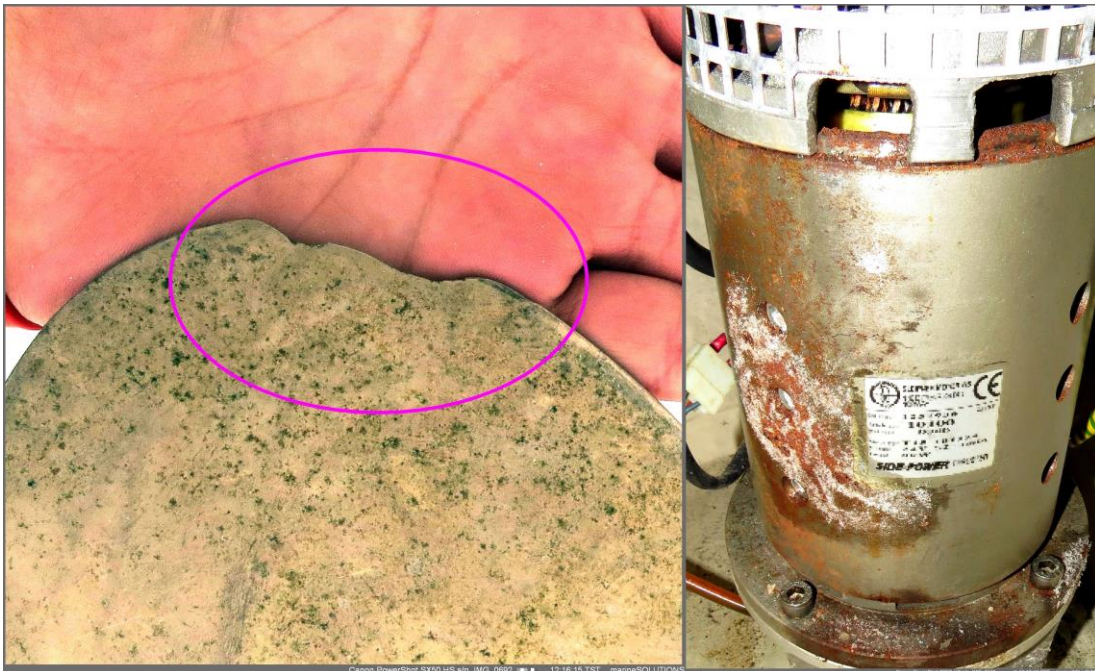
- 11.1 All the anodes were in need of replacement.
- 11.2 The Vessel is equipped with 3-bladed MaxProp feathering propeller. All the blades' tips were broken off, most likely due to contact with submerged object(s). No traces of grounding could be noted. All the blades can and need to be rebuilt/ replaced.
- 11.3 The electric motor of the bow thruster had started to corrode. It needs to be cleaned and painted. The unit tested as operational during the seatrial.

Above left: **One of the propeller blade's tip.** Above right: **Condition of the bow thruster's electric motor.**

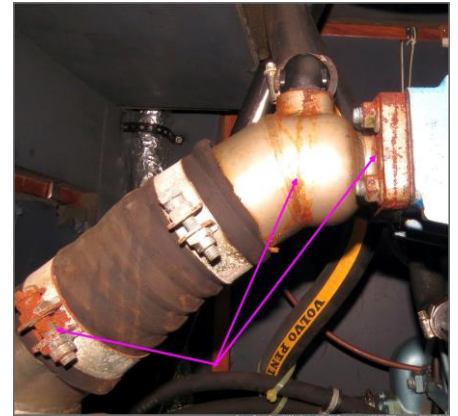
- 11.4 The stern gland was corroded and there was dirt build-up on the unit. It needs cleaning.
- 11.5 I noted rusty leak marks from the engine's exhaust elbow, elbow's joint to the engine and exhaust hose and clips of the exhaust hose. I could not detect any leak, though. The marks need to be cleaned and the areas need to be monitored.

Right: **Rusted areas on the exhaust elbow of the engine**

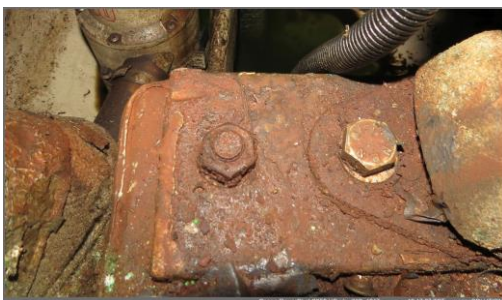
- 11.6 All the engine mounts were heavily corroded. These need to be cleaned, preferably by removing them. Replacing them may also be considered.

Right: **One of the mount of the engine which is heavily corroded**

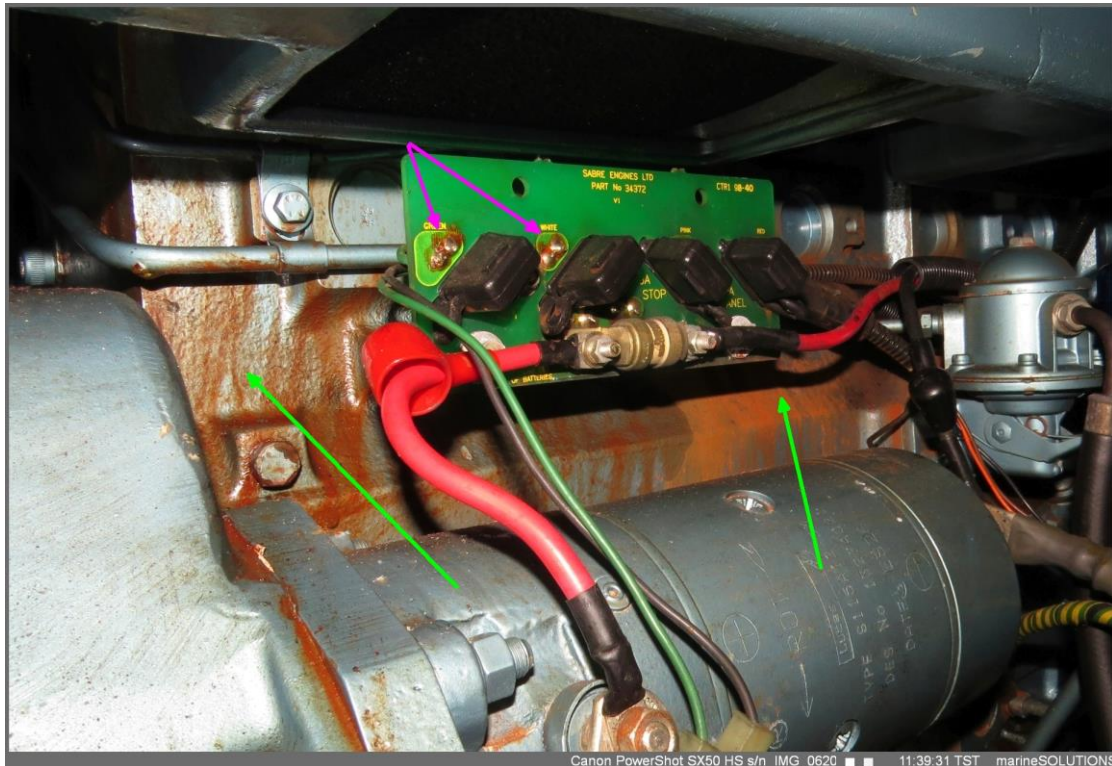
- 11.7 I noted rusty leak marks on the engine body. During my inspections I did not locate any present leak. To

- 11.8 An electronic board on the engine was left as bare, without a case. I noted some corroded sections on this board. This needs to be cleaned. Putting this board in a case is advised.

Above: Rusty leak marks (green arrows) on the engine body and corroded sections on the electronic card (magenta arrows) of the engine

be cleaned and monitored.

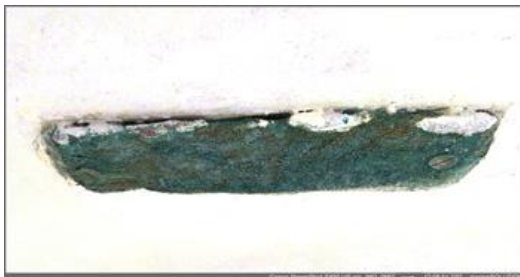
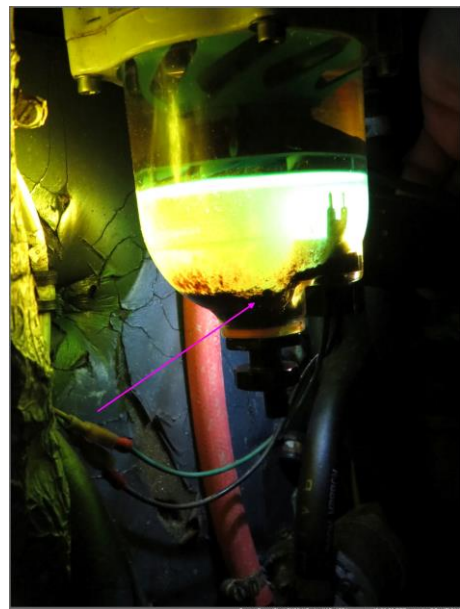
Below: Aft grounding plate

- 11.10 The Vessel is equipped with two grounding plates. The one located aft was eaten away in places and tarnished. This issue can be related the lightning incident in 20●● which was reported by the Owner – or simple aging. Unit needs to be replaced.

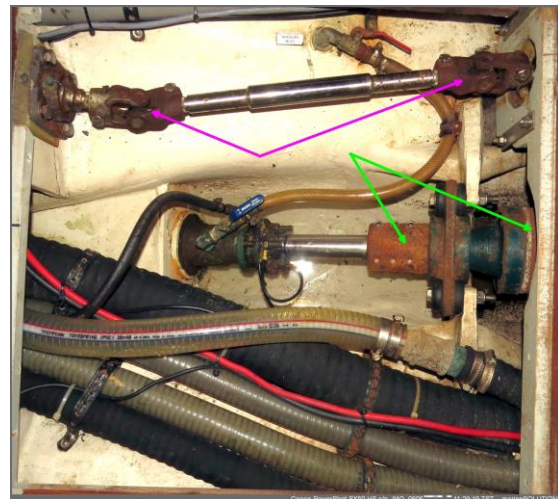
- 11.17 The anchor needs to be re-galvanized.
- 11.18 The drive train is equipped with an elastic coupling (Aqua Drive or similar). The members of the system were heavily corroded. The unit needs to be removed, serviced and reinstalled. If necessary, it needs to be replaced.
- 11.19 The members on the steering system's shaft were corroded. These need to be cleaned, preferably by removing.

Right: Elastic coupling's corroded parts indicated with green arrows and corroded members of the steering system indicated with magenta arrows.

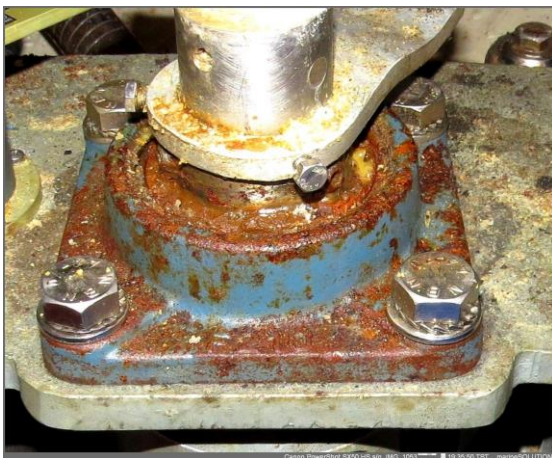
- 11.20 Rudder shaft's upper bearing in the steering compartment was corroded. This needs to be cleaned.

Left: Rudder shaft's upper bearing

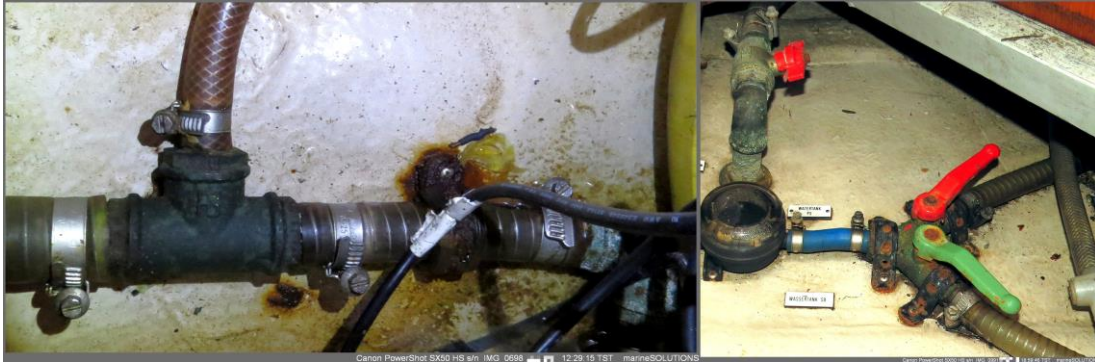
- 12.1 I noted quite a bit of salty water in the bilges of the forward hallway. This needs to be cleaned. I was unable to locate the source of the salty water during my inspections. This should be determined and corrected as required.
- 12.2 Equipment in the forward hallway bilge, as well as in the galley's forward bilge, such as cable and hose fasteners, label mounting screws, strainers, valves, etc. were corroded. These need to be cleaned or replaced.

Above left: **Equipment in the forward hallway bilge.** Above right: **Equipment in the galley's forward bilge**

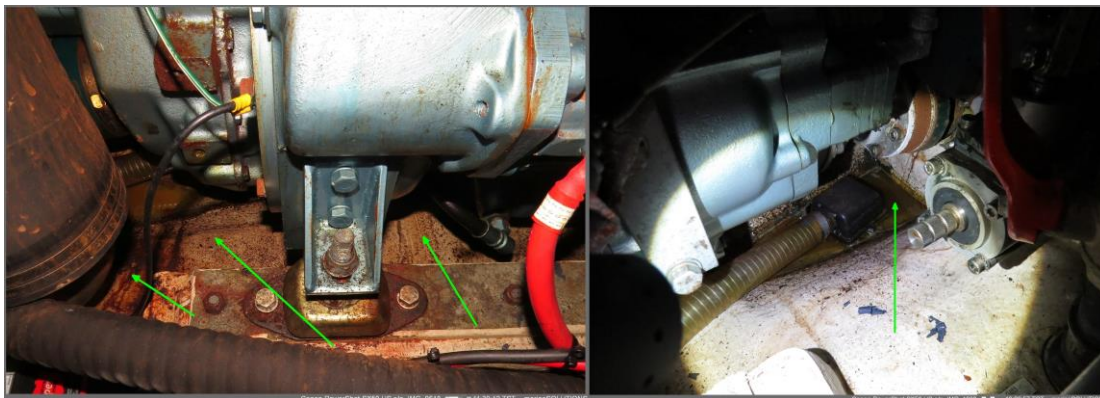
- 12.3 The bilges under the engine were very dirty. I noted blue/green colored liquid assumed to be coolant, used oil most probably from the engine's servicing and light colored oil most probably from the gearbox's servicing times. Also, there were rusty leak marks from the exhaust line of the engine. These need to be cleaned thoroughly.

Above: **Dirty bilges under the engine**

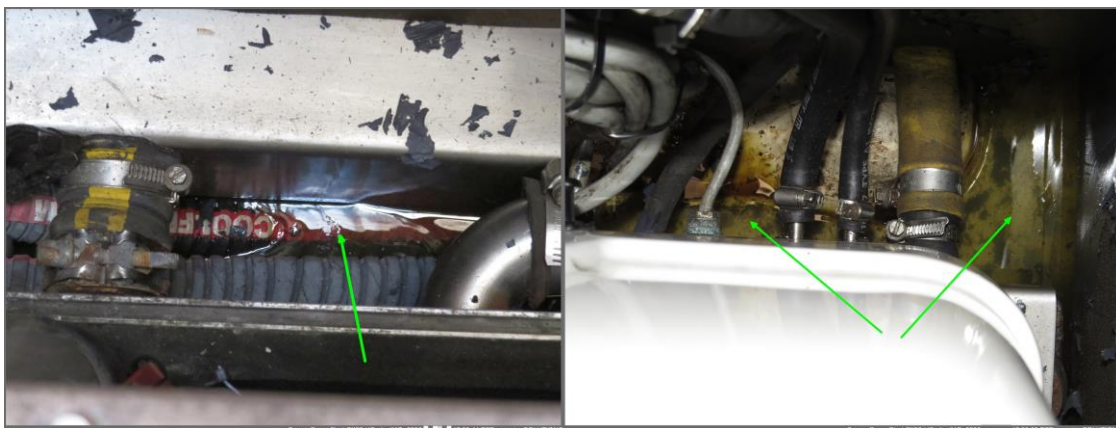
- 12.4 I noted oily water under the generator's cocoon. This needs thorough cleaning.

Above: **Oily water under the generator**

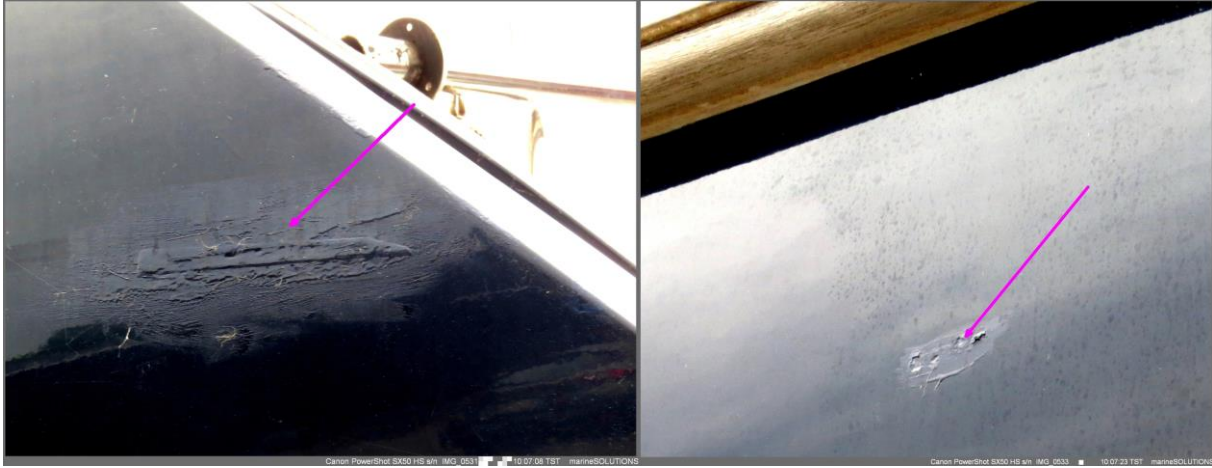
- 13.1.1 I noted several repaired areas on the topsides. The repaired areas were in various sizes between D=2 cm area to D=10 cm area and the repairs were carried out in a substandard manner. Nearly all the topsides were dull. The repaired areas can be improved - however, when considering the age, condition of the remaining areas and the amount of the improper repairs on the topsides' it would be beneficial to spray the whole of the topsides at once. The transom of the Vessel was dulled, as well.

Above: Repaired areas on the topsides

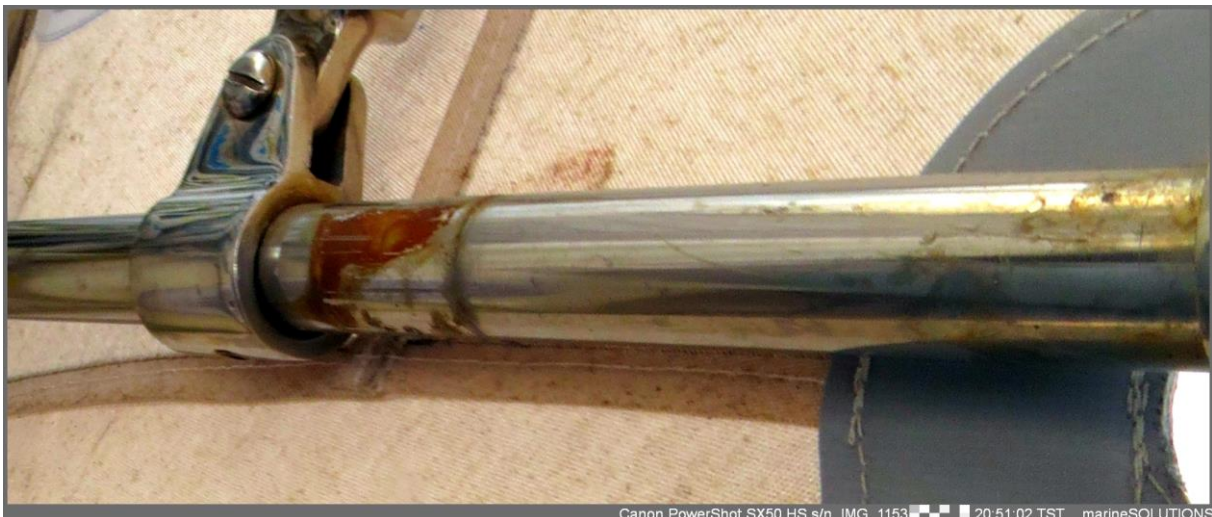
- 14.1 The gelcoat surfaces on the main deck as well as on the superstructure were dulled. These need to be treated.
- 14.2 I noted a gelcoat crack at port side of the starboard speaker in the cockpit. To be repaired.
- 14.3 Stainless steel bimini and spray hood frames need to be cleaned and polished.

Above: Spray hood frame's rusted sections

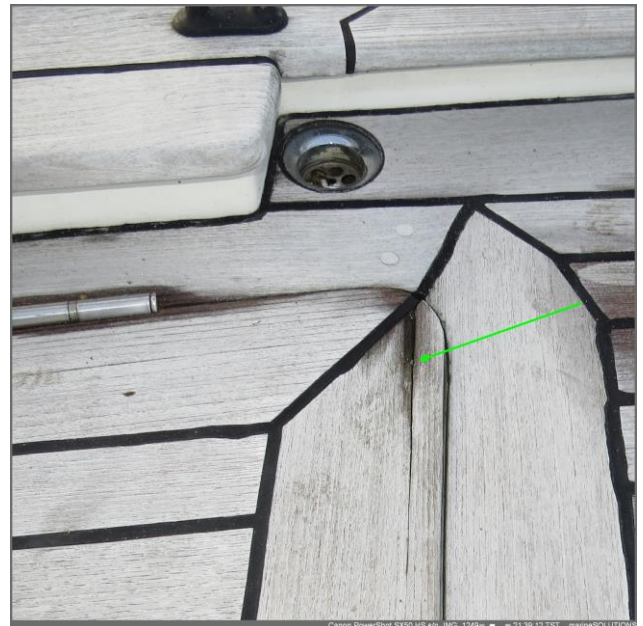
- 14.6 The retainer piston of the forward locker at main deck was heavily corroded. To be replaced.
- 14.7 There are some blackened areas and moss growth on the deck. To be cleaned.
- 14.8 A teak margin plank on the port aft locker cover was cracked. This can be and needs to be repaired.

Right Cracked teak plank

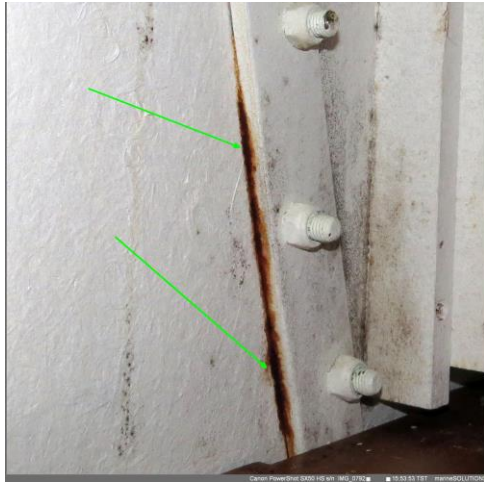
15.1 The chain plate of the port D1 wire had started to corrode. To be removed, inspected and treated.

Left: Chainplate of the port D1 wire

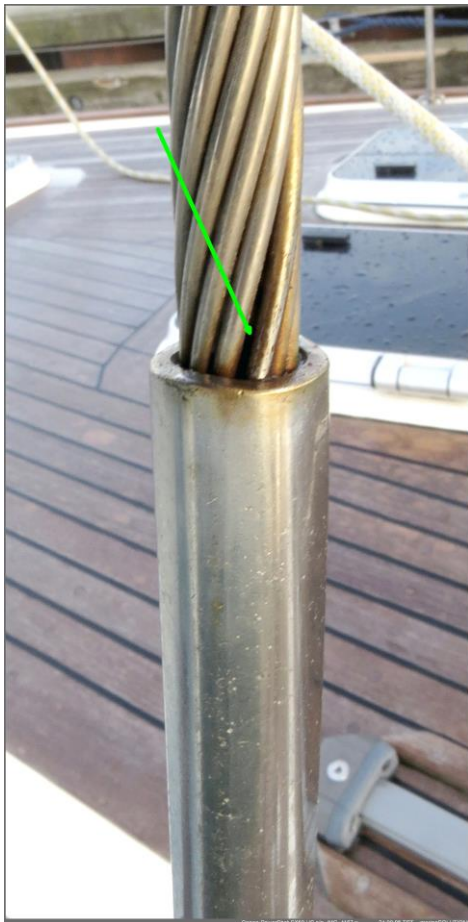
15.2 The port V1F wire had started to uncoil adjacent to the lower fitting. This wire is unsafe and needs to be replaced soon.

Left: Uncoiling port V1F wire

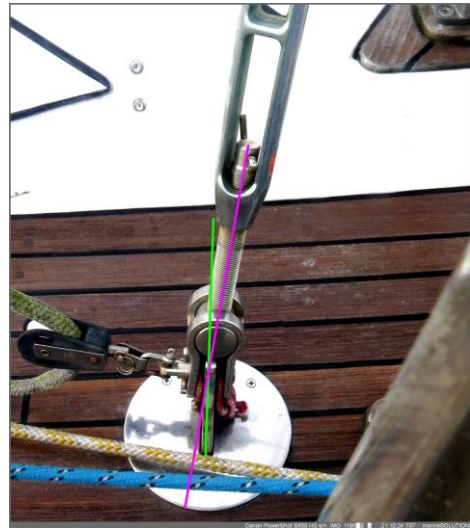
- 15.3 Both D1 wires are not in alignment with their chain plates. Realignment of the chain plates needs to be considered. Toggles are no cure.

Right: **Port D1 wire's connection to chainplate not as aligned correctly**

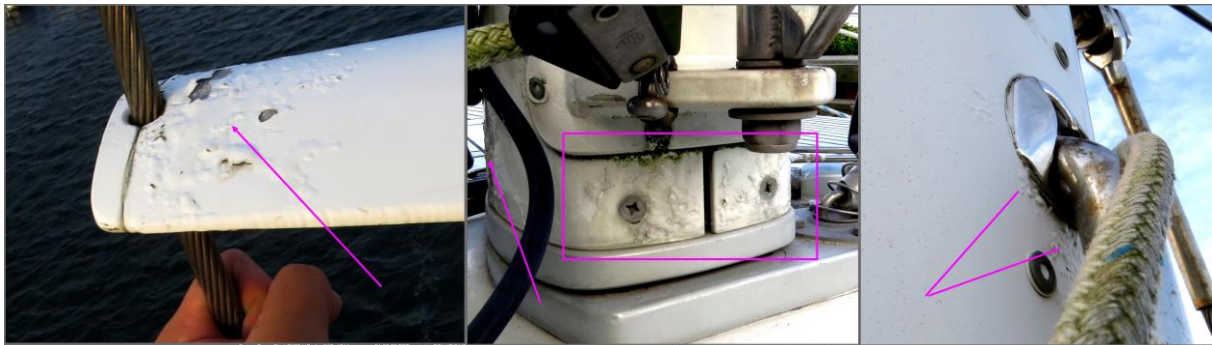
- 15.4 I noted corroded sections on the mast as well as on the spreaders where the areas are contacted with stainless steel equipment, bolts, wires, etc. These areas need to be addressed and treated.

Above: **Corroded sections of the mast**

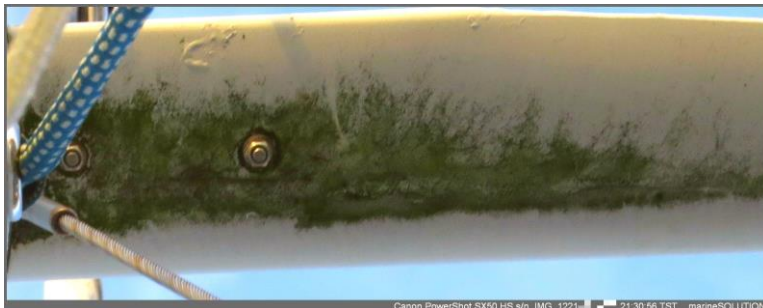
- 15.6 I noted moss growth on the spreaders lower surfaces. These need to be cleaned.

Above: **Moss growth on the starboard lower spreader**

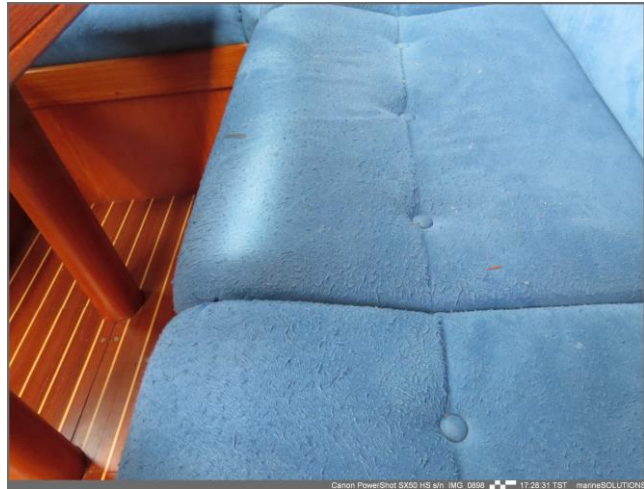
- 16.1 The upholstery of the seating group in the saloon had pilled. To be treated or replaced.

Right: **Pilled upholstery of the seating group**

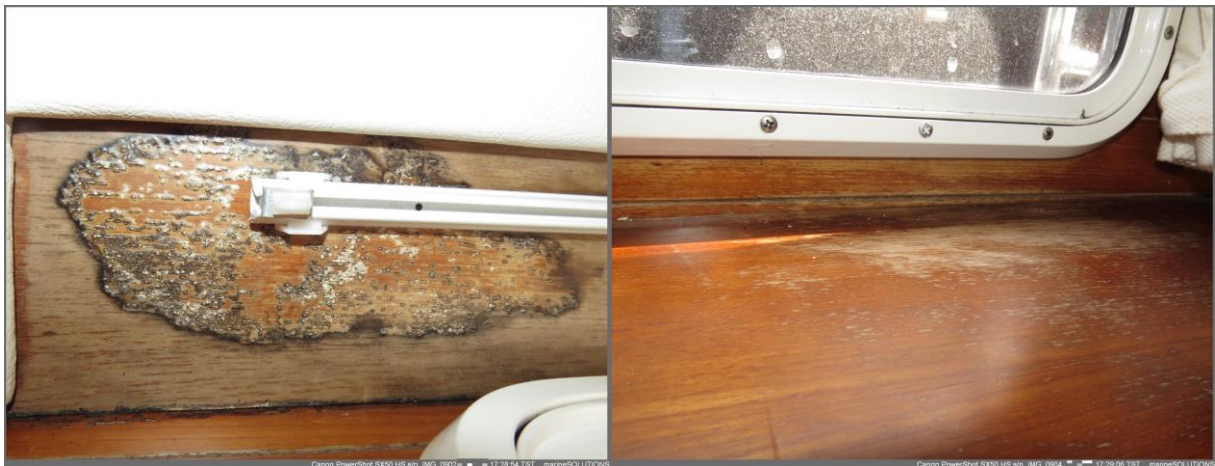
- 16.2 The ceiling above the starboard porthole of the saloon and the veneer around the porthole has water damage, likely due to leakage. These veneers need to be replaced and proper varnish needs to be applied. It should be considered that there could be color difference between aged wood around the repaired areas.

Above: **Damaged veneer and varnish around the starboard porthole of the saloon**

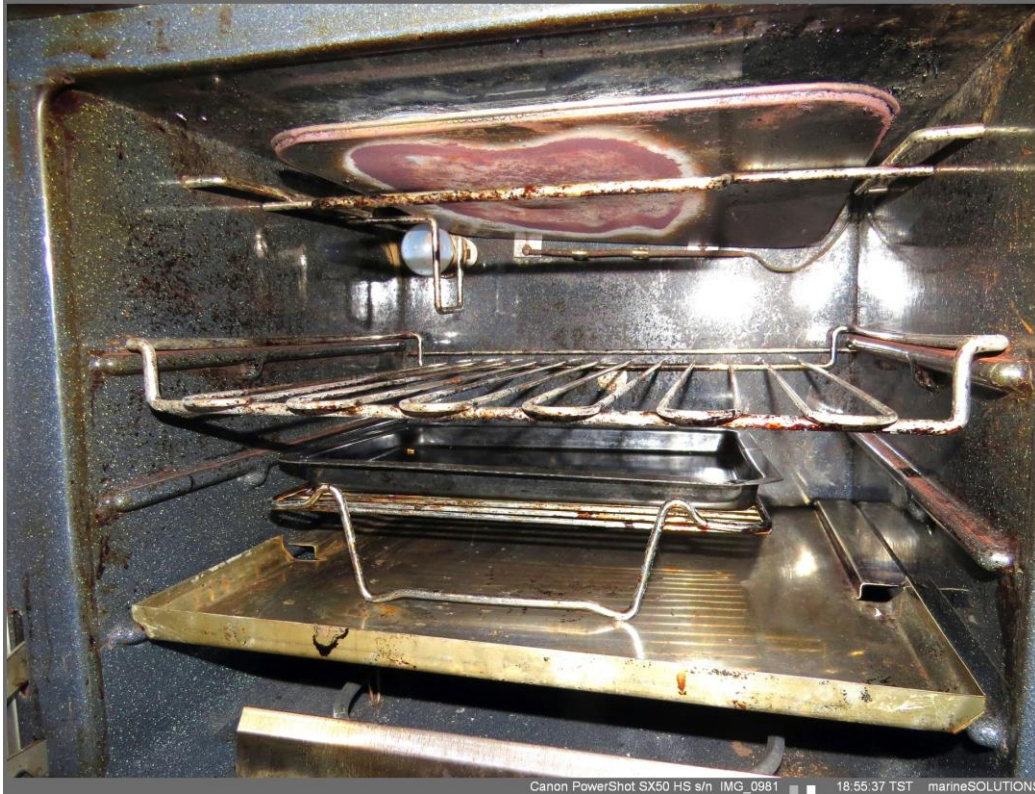
- 16.6 There is a 220 V AC oven/hob in the galley. I tested the unit as operational, however, the unit needs cleaning and some parts had started to corrode. Replacing this unit needs to be considered. Many vessels in this category prefer the disadvantages of carrying LPG to those of starting a generator for a simple coffee. Thus, as a replacement may be on the agenda, replacement with a marine LPG hob/ oven should be considered. However, the complications of LPG piping and canister storage in accordance with related guidelines/rules need to be kept in mind.

Above: The condition of the oven/hob

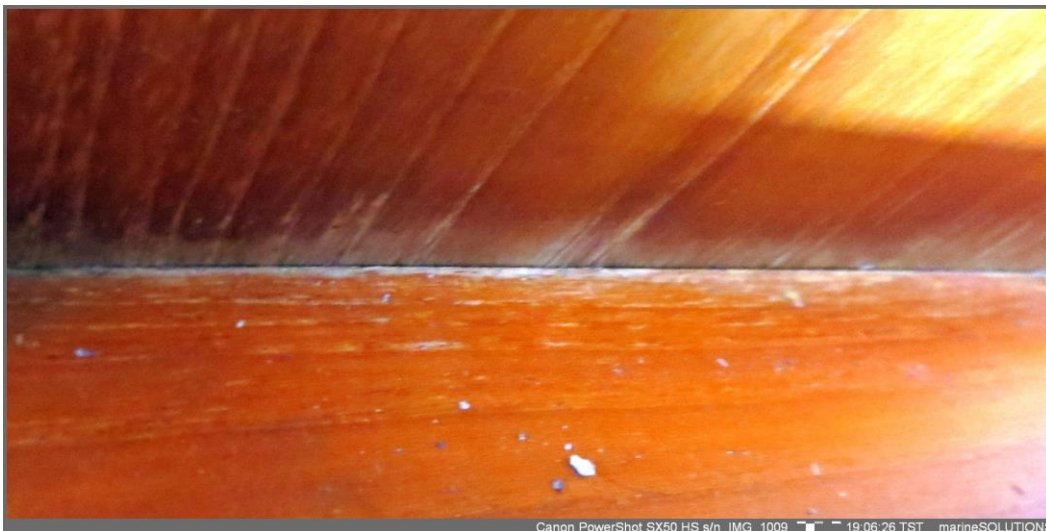
- 16.7 The veneer below the starboard porthole in the galley was damaged by water leaking from the left-open porthole. Damaged sections of veneer need to be replaced and proper varnish needs to be applied. It should be considered that there could be color difference between aged wooden surfaces around the repaired areas.

Above: Damaged veneer below the starboard porthole of the galley

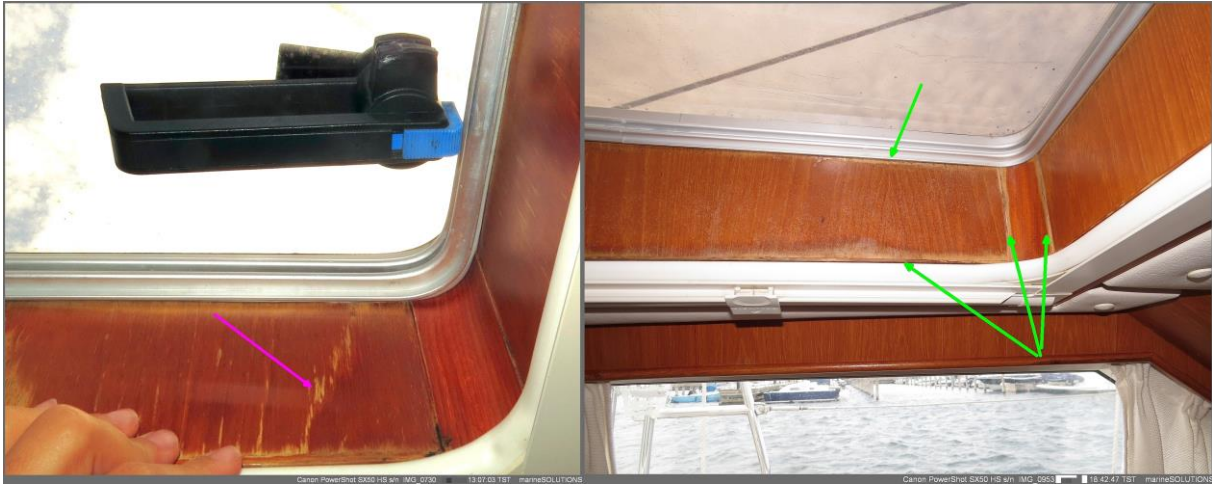
- 17.1 The wooden frames of the all hatches had water damage. The veneer had started to detach and the varnish on them was peeled off in places. These frames need to re-varnished and veneers need to be replaced in the damaged areas.

Above left: **Wooden frame of the forward cabin's hatch.** Above right: **Wooden frame of a hatch in saloon**

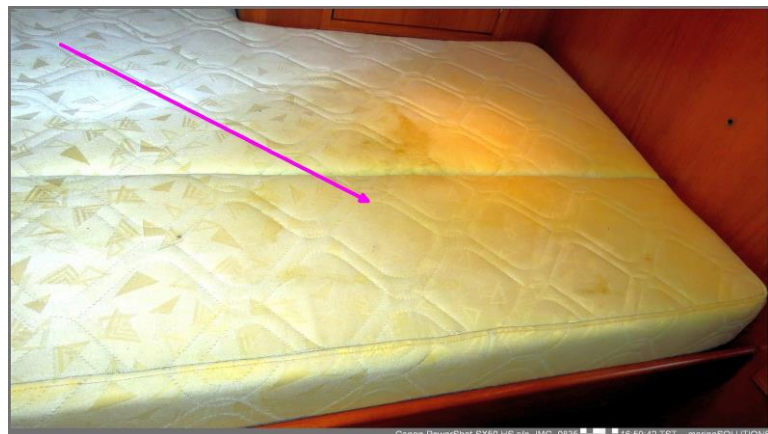
- 17.7 I noted oily stains on the both bed mattresses in the starboard cabin. Also there were oil remnants on the bed headlight located at aft bulkhead of the cabin. It was reported that the hydraulic fittings of the boom furling system had been damaged and that hydraulic oil had leaked from the cabin's hatch into the cabin. Both mattresses need to be replaced and oil remnants need to be cleaned thoroughly.

Above: **oil remnants on the upper bed mattress**

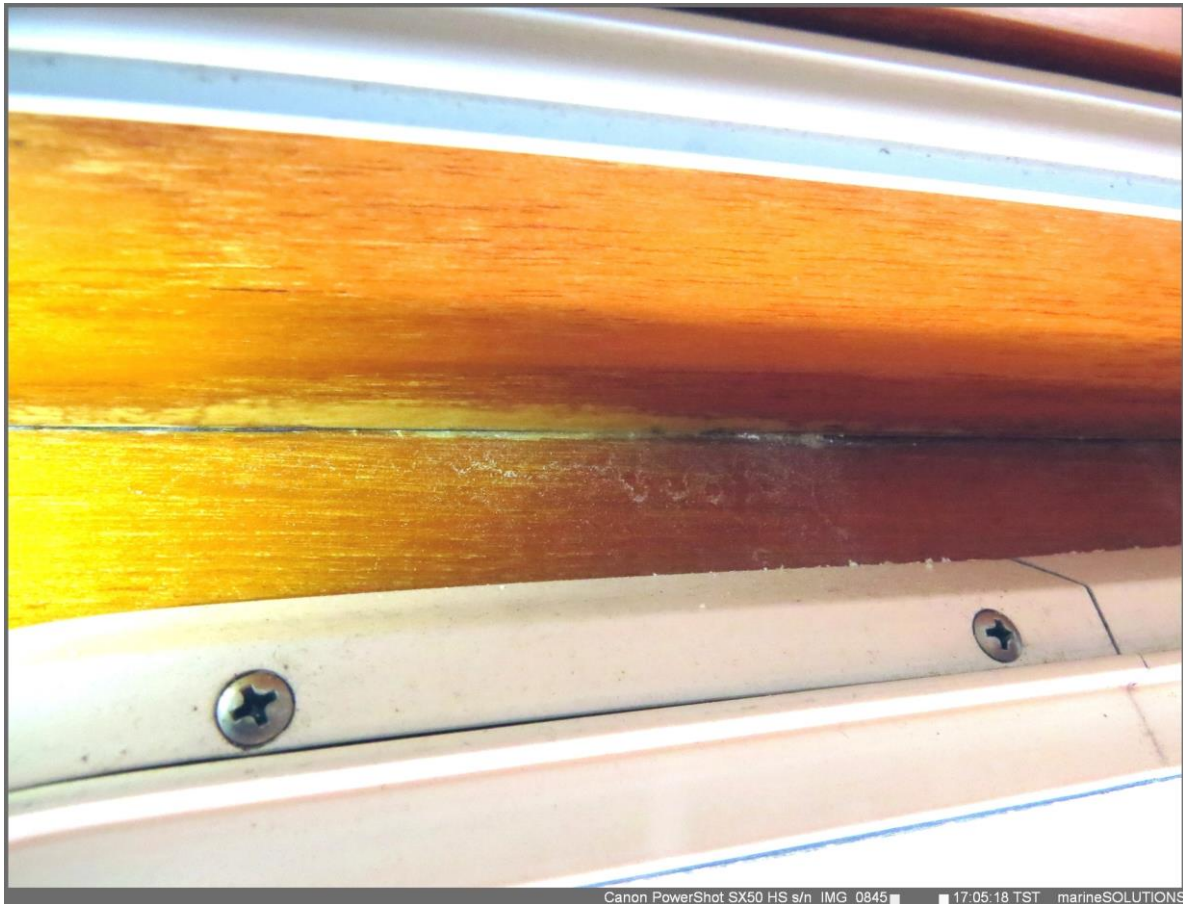
- 17.8 The veneer above the porthole in the starboard cabin has water damage, likely due to leakage. The area needs to be re-varnished. Replacing veneer needs to be considered if needed.

Above: Veneer above the starboard cabin's porthole
