Walkthrough Condition Survey Report

<i>Name Of the Vessel</i>	E●●●●m	<i>Flag</i>	USA
<i>Port of Hail</i>	Wilmington, Delaware	<i>Documents To The Vessel</i>	Boat Registration Certificate, No. DL●●●F, See Attachment 18.3 and 18.4.
<i>HIN</i>	FR-SP●●●●B●● HIN not affixed to hull starboard aft in breach of standards. Secondary HIN was located with help of manufacturer and was seen by Surveyor. HIN should be affixed in retro to hull in manner prescribed by ISO 1●●●●

<i>Date of Manufacture</i>	201●	<i>Manufacturer</i>	Jeanneau/ SPBI/ France
<i>Length o A</i>	17.78m	<i>Type Of Vessel</i>	Sailing Yacht, Jeanneau 57, S057D
<i>Length o D</i>	17.28m	<i>Material hull, deck, superstructure</i>	GRP
<i>Draft</i>	2.25m	<i>B_{max}</i>	5.00m

<i>Survey's Scope</i>	Walkthrough Condition Survey
<i>Surveyor(s) on Site</i>	Capt. Naci Arıcı and Mr. Cem Baykent, BSc.
<i>Date, Time And Place of Survey</i>	14.●●.201●, 10:15 – 16:45, Göcek, Turkey
<i>Met Conditions during the Survey</i>	At times heavy rain, impairing work to some degree
<i>Those Present During Survey</i>	Capt. O●●● U●●●, Skipper; Mr. E●●● Ö●●●, Jeanneau Turkey
<i>Afloat/ On Hard</i>	Both
<i>Instructor</i>	Mr. G●●● Y●●●, Israel

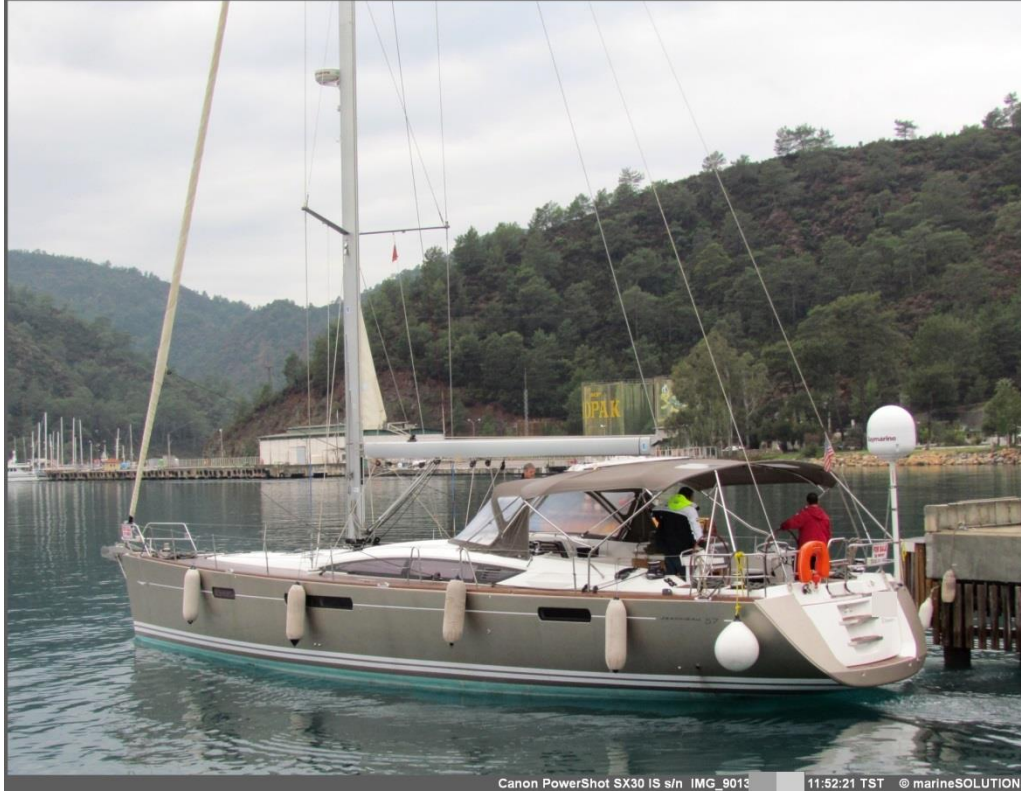
The Vessel is a production boat with little additional if any. The vessel is in good condition for her age and make.

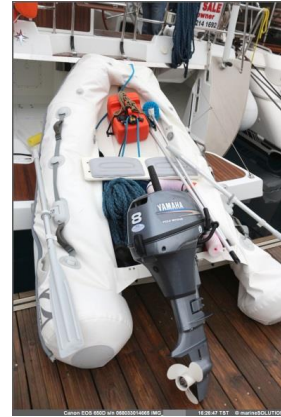
<u>General</u>	Zodiac Cadet 250 Rib Boat (s/n Z●●●) in good condition.
<u>Hull</u>	Polyester and PVC
<u>Engine</u>	Yamaha 8 HP Four Stroke outboard engine. Not tested.
