REPORT

Pre-Purchase Condition Survey Report**1 Particulars of the Vessel**

<i>Name Of the Vessel</i>	S●●●●	<i>Flag</i>	British
<i>Port of Hail</i>	London	<i>Documents To The Vessel</i>	Certificate of Registry (See Attachment 23.2) Tonnage Certificate (See Attachment 23.1)
<i>HIN</i>	n/a	<i>Design Cat.94-25-CE</i>	n/a
<i>Date of Manufacture</i>	20●●	<i>Registration Number</i>

<i>Survey's Scope</i>	Pre Purchase Condition Survey
<i>Surveyor(s) on Site</i>	Tufan Tunalı, Nav. Arch, Yusuf Civelekoğlu, CMI
<i>Date, Time and Place of Survey</i>	7.●●.20●●, 14:30 – 21:45, 8.●●.20●●, 10:00 – 19:15, 9.●●.20●●, 09:45 – 13:15 ¹ Porto Mirabello, La Spezia, on hard and at berth; and in the Bay of La Spezia, seatrial on 7.●●.20●●
<i>Met Conditions during the Survey</i>	Very hot, over 35 °C, and very humid.
<i>Those Present during Survey</i>	Staff from the manufacturing yard. Surveyor P●●● R●●● at times.
<i>Afloat/ On Hard</i>	Both
<i>Instructor</i>	Mr. O●●● E●●●, N●●●●●●● T●●●

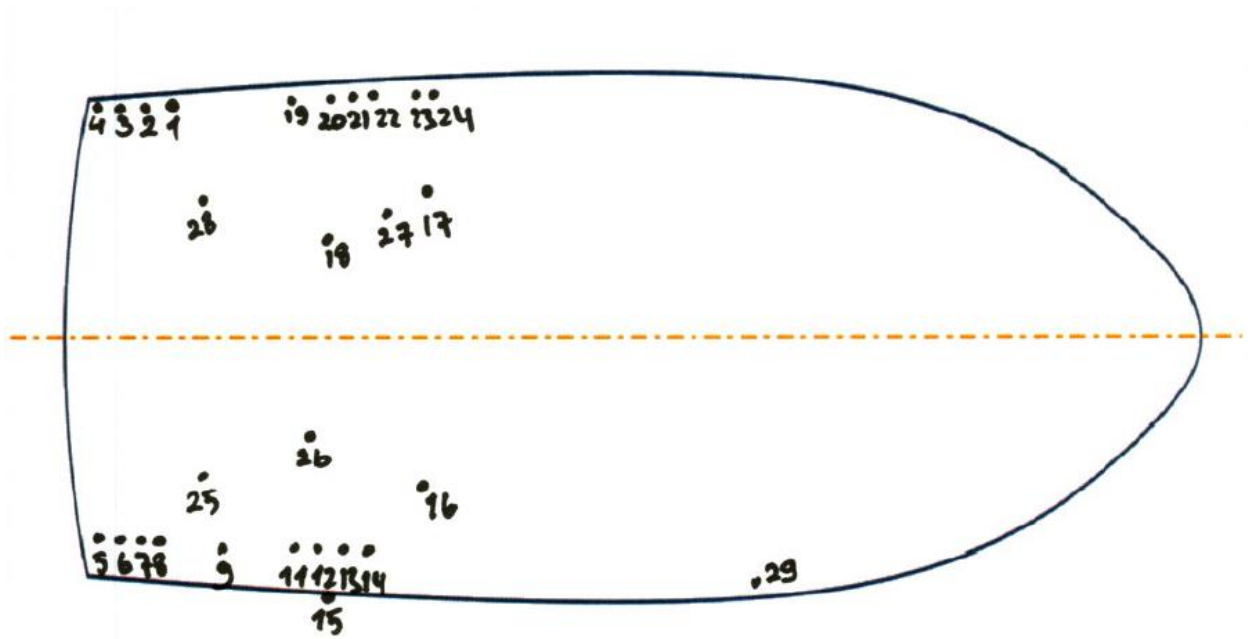
rflly ⁵						
17	Butte rflly	L	Inlet	yes	Good	Plumbing	Handles corroding
18	Gate	S	Inlet	yes	Tarnished	Plumbing	
19	Gate	S	Discharge	yes	Tarnished	Plumbing	
20	Gate	S	Discharge	yes	Tarnished	Plumbing	
21	Gate	M	Discharge	yes	Tarnished	Plumbing	
22	Gate	S	Discharge	yes	Tarnished	Plumbing	
23	Gate	S	Discharge	yes	Tarnished	Plumbing	
24	Gate	M	Discharge	yes	Tarnished	Plumbing	
25	Gate	S	Inlet	yes	Tarnished	Plumbing	
26	Gate	S	Inlet	yes	Tarnished	Plumbing	
27	Gate	S	Inlet	yes	Tarnished	Plumbing	
28	Gate	S	Inlet	yes	Tarnished	Plumbing	
29	Gate	S	Discharge	yes	Tarnished	Plumbing	Surface corrosion at plumbing noted. Address issue.

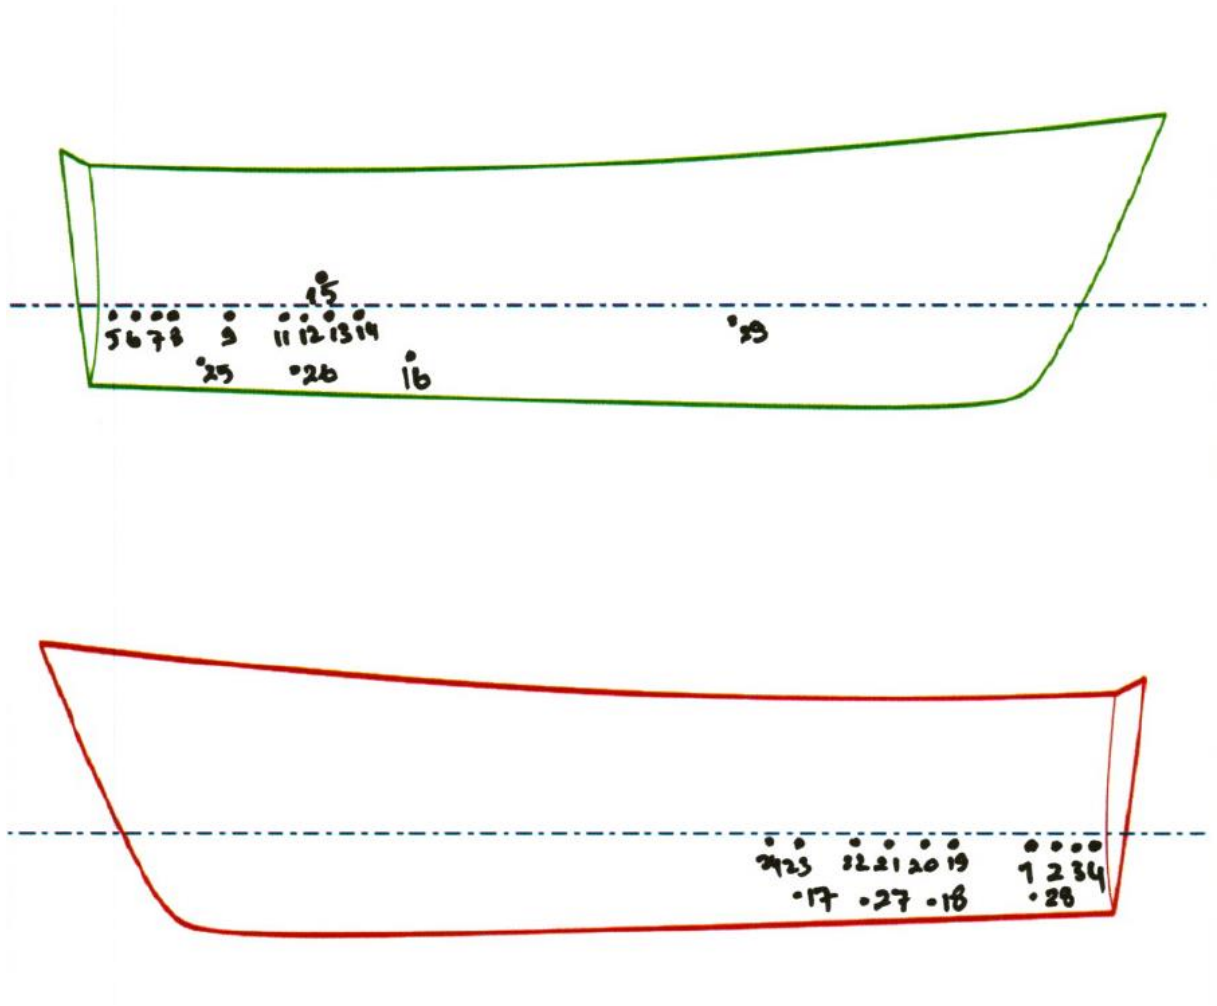
⁵ Butterfly valves are equipped with locking handles. All handle locks' function has been tested positively.

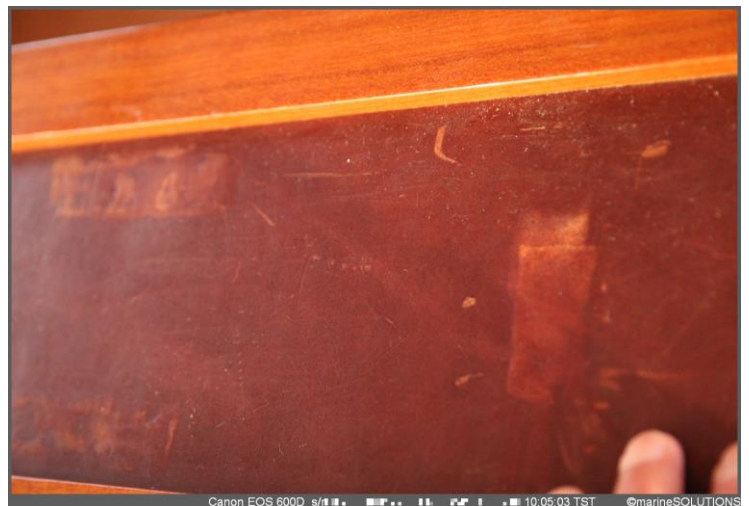
Could not be inspected in detail.

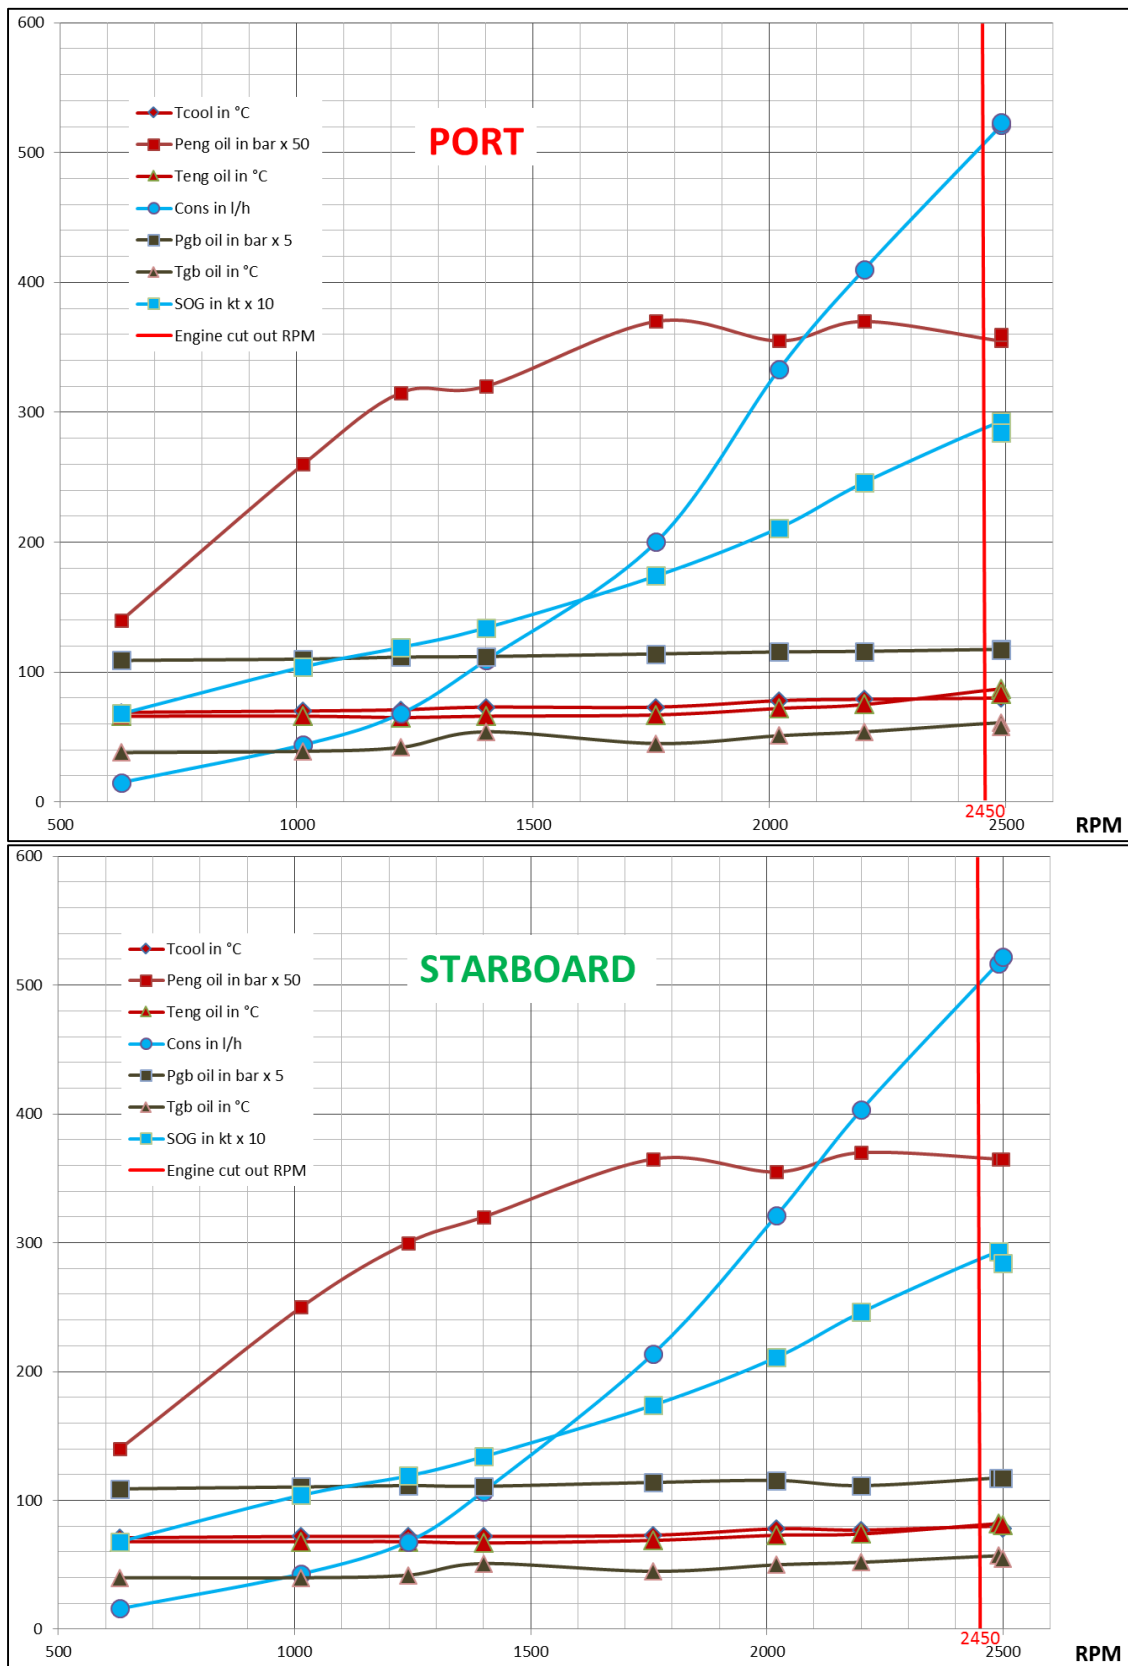
Seatrial data plotted the Port engine (above) and the Starboard engine (below) - in both instances as a function of the respective engine revs. For better visibility, the engine oil pressure, the gearbox oil pressure and the Speed over

Ground have been displayed with x50, x5 and x 10 respectively. No inconsistencies or unexpected differences between engines noted.

The manufacturer's published engine parameters have not been studied in detail, however, the behaviour of the engine parameters are considered as predominantly symmetric between engines and as expected. Note slight over revving, 40 – 50 revs, of both engines at full throttle. Issue should be consulted with an engineer, experienced with these engines, but is believed to be within acceptable limits. As the Vessel was fitted after December 2008 fitted with propellers of lesser diameter, pitch and blade number (see Section 9.5) it is believed that the engines are over revving to catch the full load.

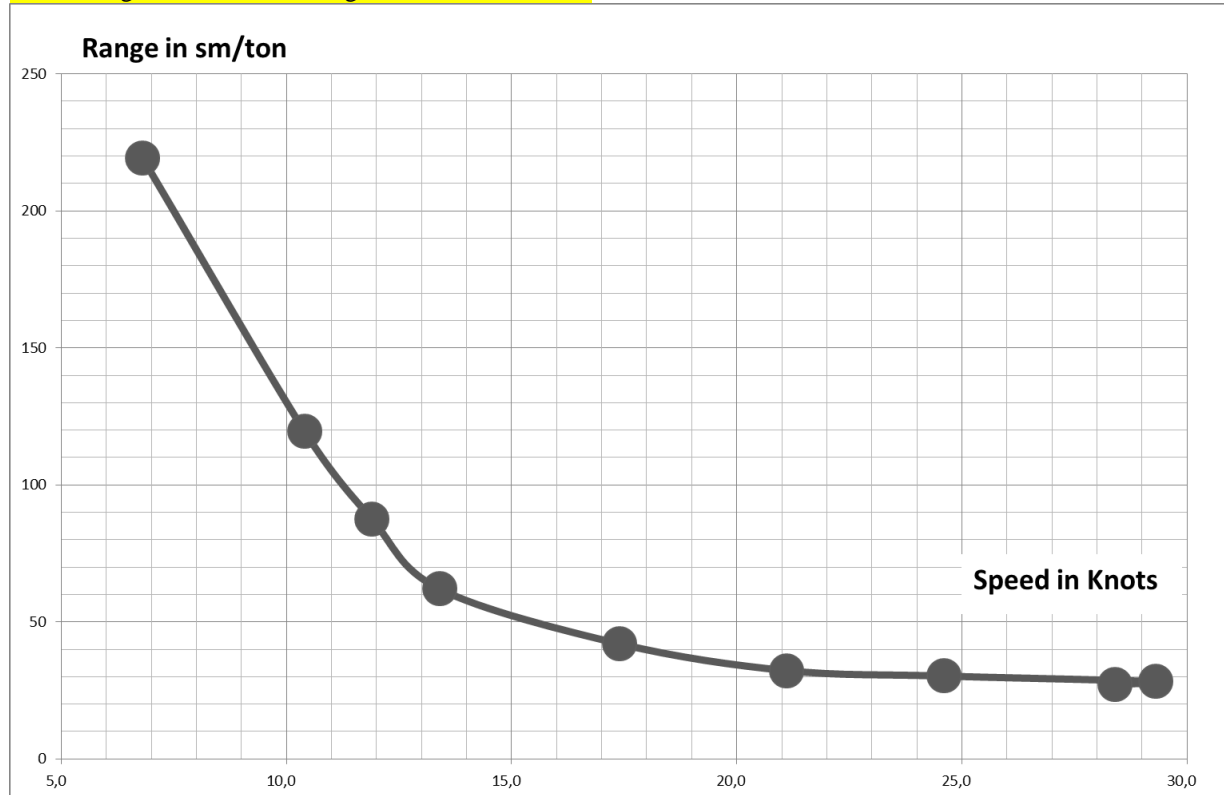
Derived Range (per ton bunker) of Vessel. In the cruising operation range of Vessel about 50 sm/tons is performed.

Engines were noted as fluid tight, if not noted otherwise in Section 9. Engine and propulsion performance deemed satisfactory.

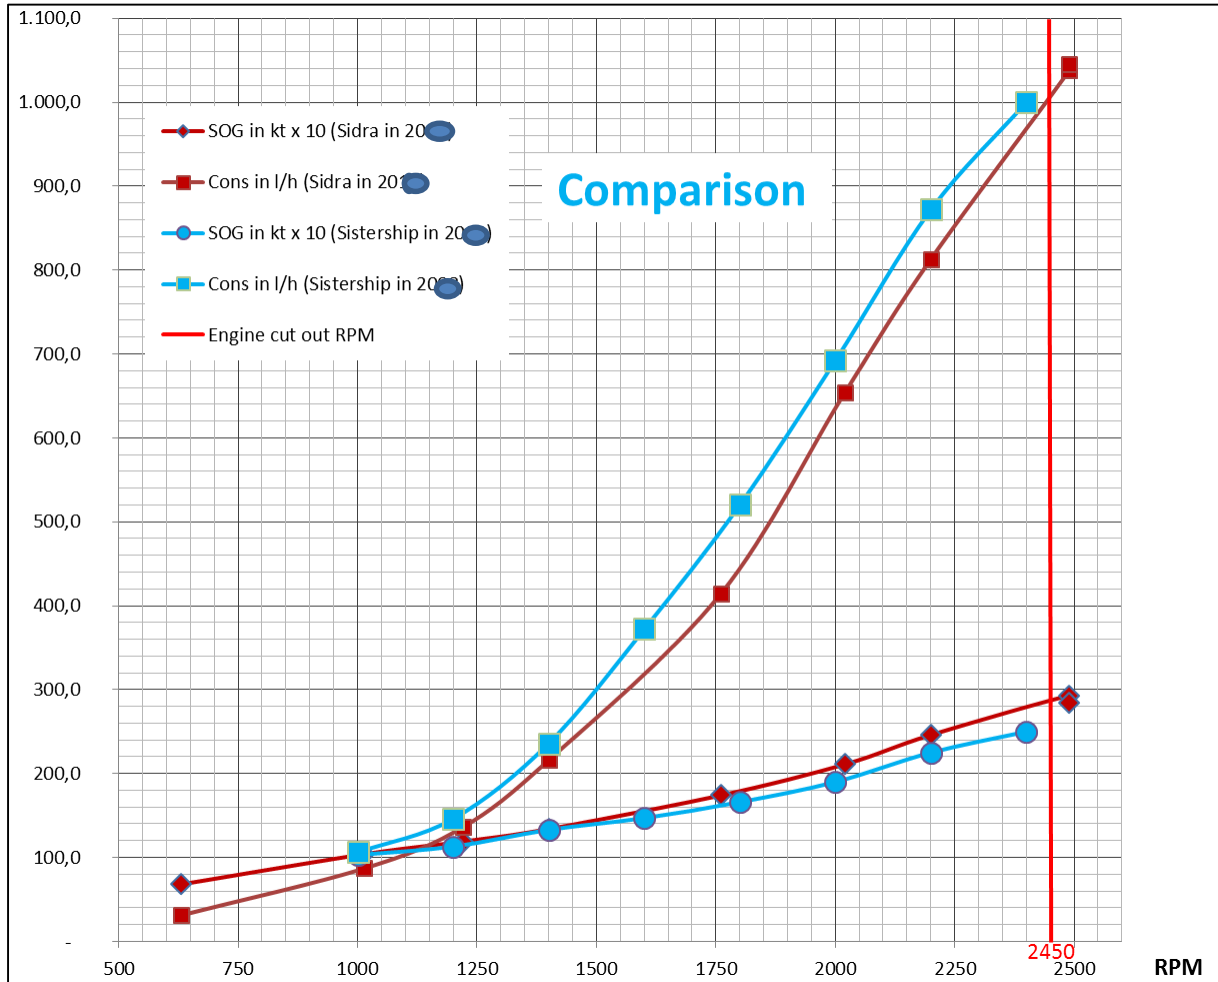
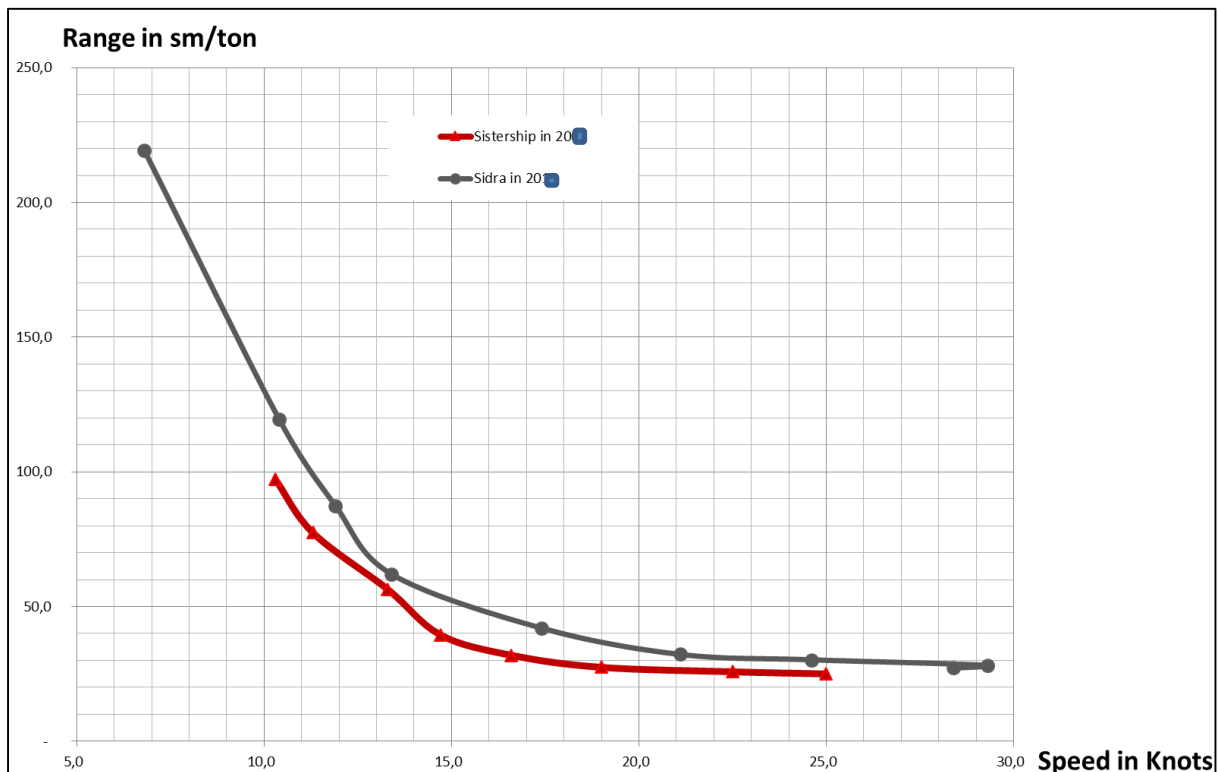
We had access to a seatrial for a sistership. We know that it must have been SL ●●●, and that that seatrial was carried out on 25.●●.20●● with 12 knots winds from SO and with the sea state F1. No info about the load of the Vessel, her fouling condition and other parameters could be obtained. However, as the data appeared reasonable we performed a comparison and can conclude that at the same engine revs our subject Vessel performed up to 2 knots better than her sistership, hereby consuming up to 80 l/h less.

In spite of the missing parameters a comparison appears sensible.
