REPORT

Pre-Purchase Condition Survey Short-Report**1 Particulars of the Vessel***Name Of the Vessel* s/y A●●●●●●●● I●*Flag* Denmark*Port of Hail* H●●●●●●k*Documents To The Vessel* n/a. See Section 7*HIN*

*Manufacturer* Conyplex BV*Type* Sailing Yacht 48CS*Date of Manufacture* 20●●*Length oA¹* 14,83 m*Draft* 1,89 m.*B_{max}* 4,25 m.*Material hull, deck, superstructure* FRP*CE Plate*

**2 Particulars of the Survey***Survey's Scope* Pre-purchase condition survey with short report of deficiencies only*Surveyor(s) on Site* Mr. Tufan Tunalı, Naval Architect and Marine Engineer*Date, Time and Place of Survey* 28. ●●.20●●, 08:45 – 22:10, ●●●●●●●●, Denmark*Met Conditions during the Survey* Rainy at times and fresh breeze*Those Present during Survey* Mr. P●●●● M●●●●●●●● (the Owner) and Mr. H●●●● P●●●● (from the Brokerage)*Afloat/ On Hard* Both*Instructor* Mr. J●●●● S●●●●●●●●**(For the Surveyors' Opinion please see Section 18 below.)**¹ All dimensions are taken from the owner's manual of the Vessel.

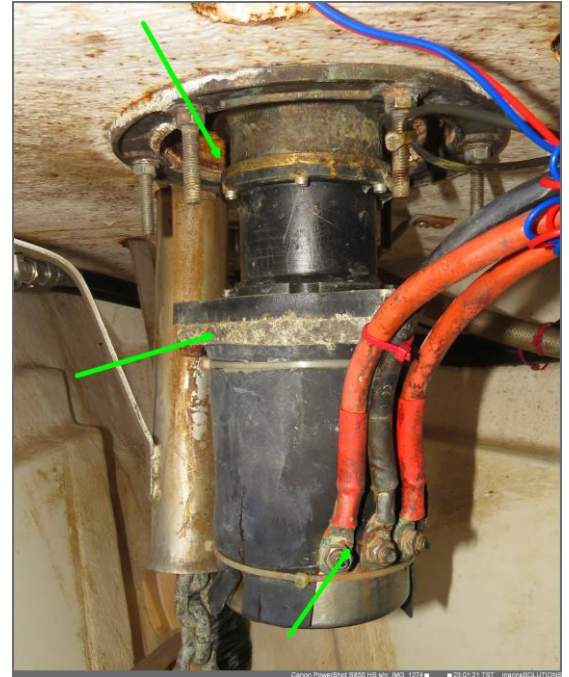
- 11.17 The anchor needs to be re-galvanized.
- 11.18 The drive train is equipped with an elastic coupling (Aqua Drive or similar). The members of the system were heavily corroded. The unit needs to be removed, serviced and reinstalled. If necessary, it needs to be replaced.
- 11.19 The members on the steering system's shaft were corroded. These need to be cleaned, preferably by removing.

Right: Elastic coupling's corroded parts indicated with green arrows and corroded members of the steering system indicated with magenta arrows.

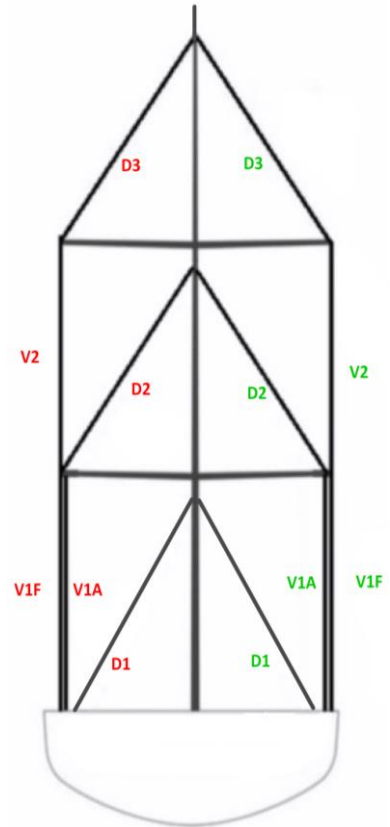
Right: Wire layout of the Vessel looking from the aft
